WASHINGTON STATE HISTORIC COUNTY COURTHOUSE ASSESSMENT

PREPARED FOR THE WASHINGTON STATE OFFICE OF ARCHAEOLOGY AND HISTORIC PRESERVATION

JUNE 2003

Summary

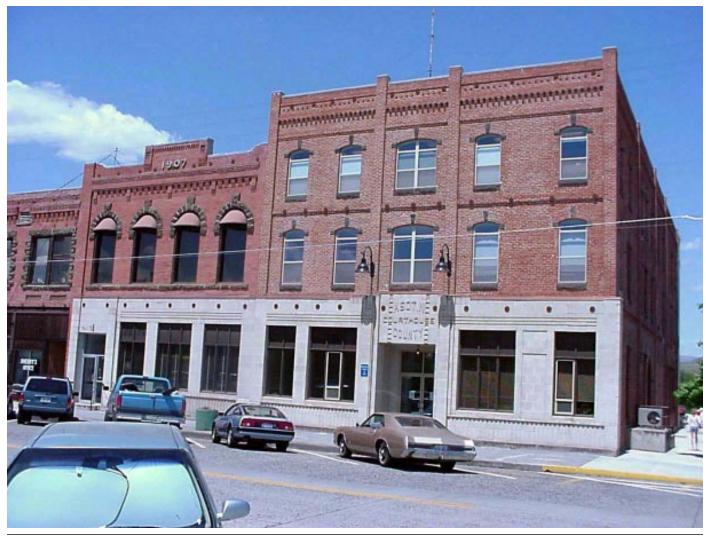
PRIMARY FACADE.

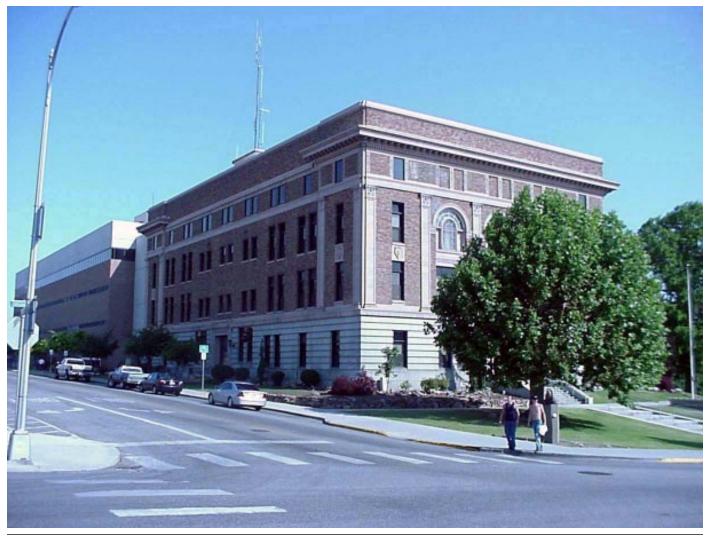
REAR FACADE.

Have a capital facilities plan. Floor settled, carpet needs to be replaced, maintenance, needs exterior cleaning.

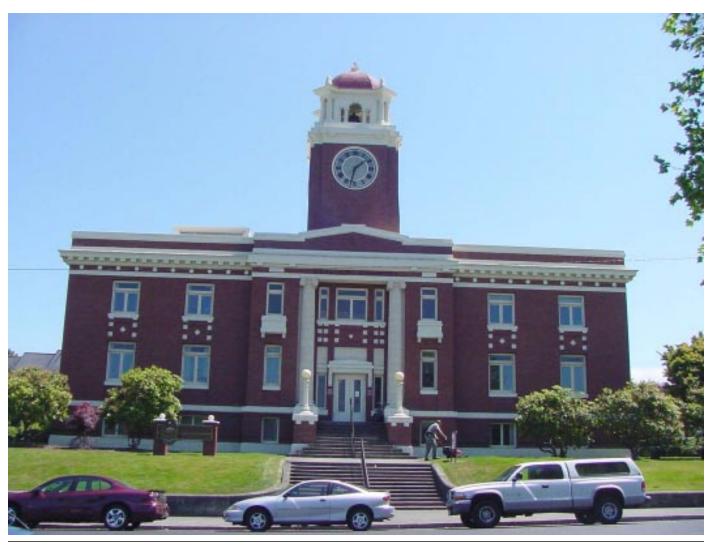
PRIMARY FACADE.

Original decorative terazzo floors. Original basic floor plan. Late deco brass work. Original marble wainscotting. Ceilings dropped. Windows have been replaced. Exterior painted concrete is in good condition.

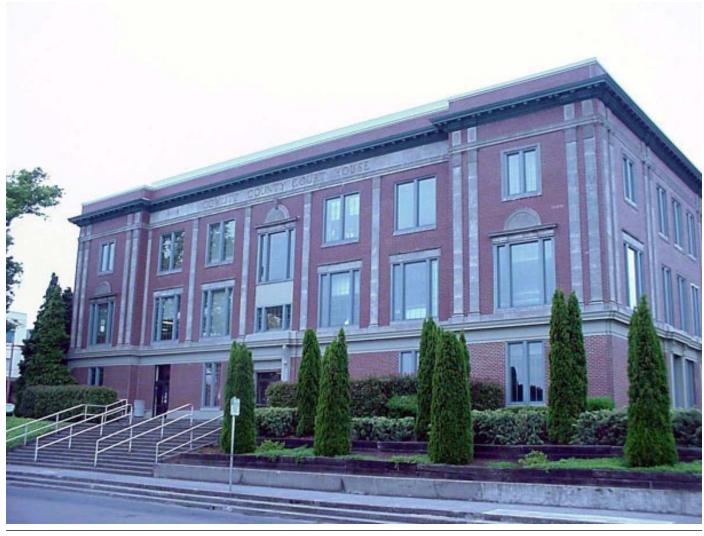
PRIMARY FACADE.

Good to excellent. Rusticated stone ground floor base with red brick masonry on upper floors. Timber frame open tower. Interior woodwork, doors, stair rails and casings intact. Courtroom intact and used. Furniture partially original.

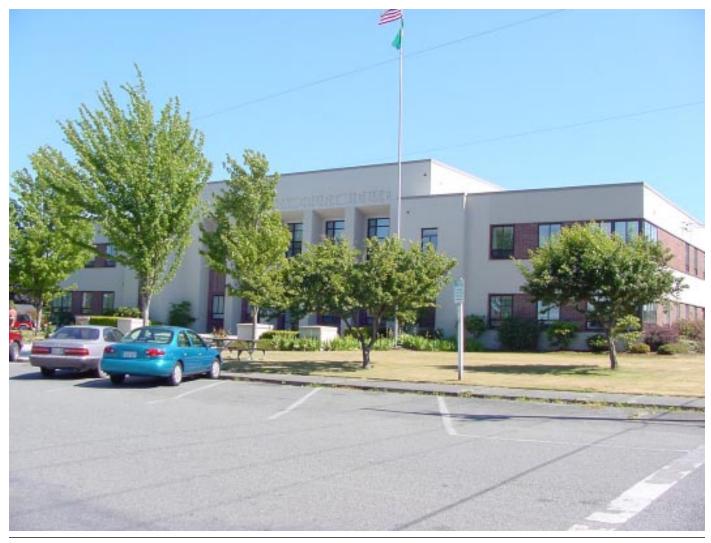
PRIMARY FACADE.

Reasonable condition for age. Needs restoration. Much of what was original remains intact, very little historic fabric has been impacted.

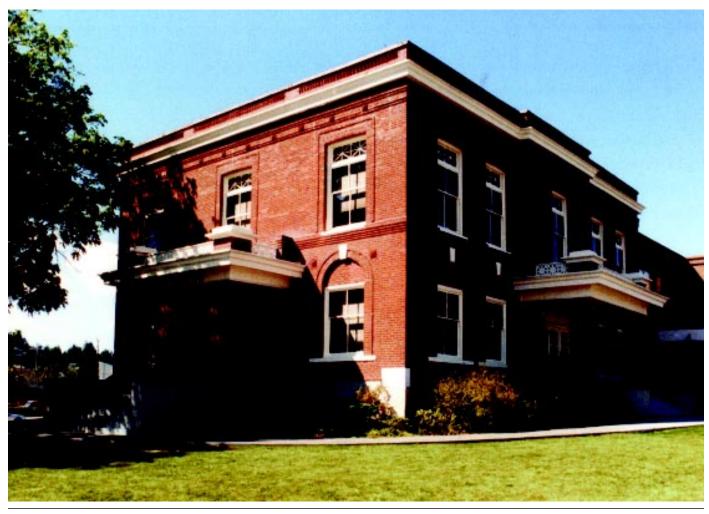
PRIMARY FACADE. SOURCE: SAN JUAN COUNTY.

Good to fair. Original wood windows, need paint. Some vinyl/metal on east elevation/some tile infill. Entry, lobby, stairs, and corridors all original configuration. Terrazzo floors. Interior walls with plaster faux stone finish. Top floor west corridor has structural crack from earthquake. No attached buildings. Security utilizes most of entry lobby.

Replace original elevator 50K. General maintenance 450K. Roof replacement 75K. Remove steel jail box from roof 10K. Seismic assessment 25K.
