# HOW TO WORK WITH STOREFRONTS OF THE MID-TWENTIETH CENTURY

A Mid-Twentieth Century Storefront Components Guide

National Main Streets Conference, Philadelphia, April 2, 2008

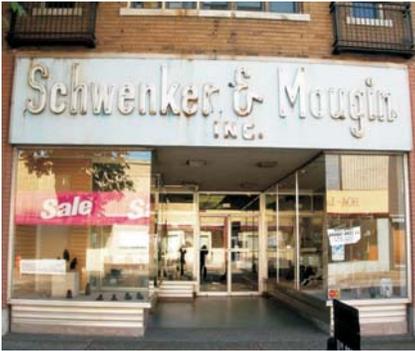
In the mid-century asymmetrical display windows and recessed entries provided room for additional display and a small “exterior lobby.” Symmetrical arched entries were popular in the 1920’s. In the mid-century “exterior lobbies” were usually asymmetrical in plan and location.

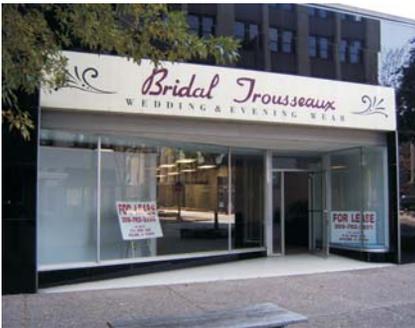
The angled front was a very common feature in post-war storefronts. They provided additional display and a small exterior lobby. The storefront would usually angle towards the asymmetrical entrance door, to sweep the buyer into the store.

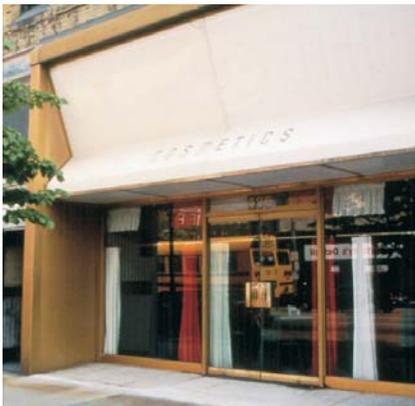
Angles were everywhere. Sometimes the front plane of the store was angled in towards the entrance, providing shading for the recessed entry, and a more dynamic approach.

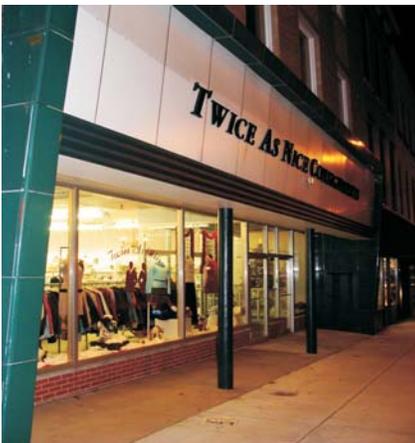
In this example the side wing-walls angled.

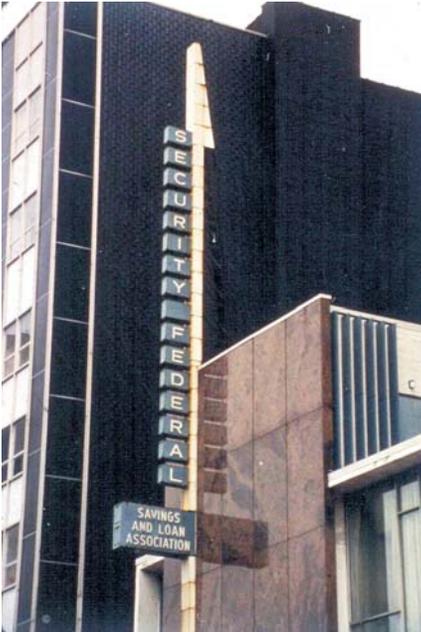
In some of the most dramatic downtown modernistic entries, pylon signage activated simple planar facades

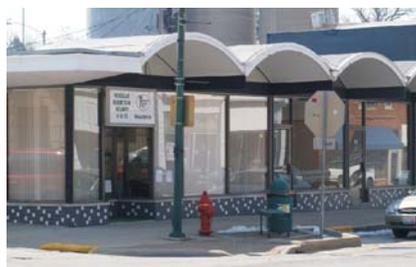
Some designers experimented with new developments in roofing technologies. This barrel vaulted roof protected the sidewalk as a canopy.

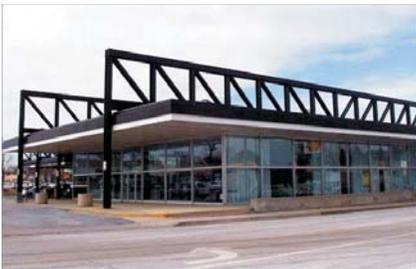
Other buildings expressed their structure as does this Villa Park, Illinois bank influenced by Mies van der Rohe.

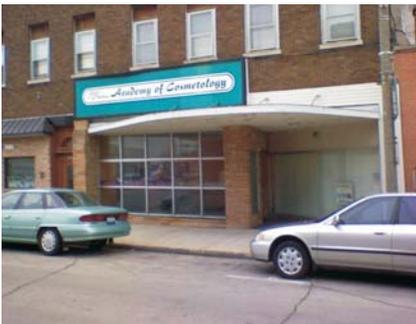
Canopies intersected the front facade to project out over the sidewalk and protect the exterior lobby and the shop windows.

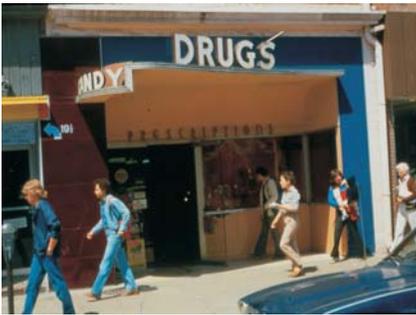
Jutting canopies replaced traditional fabric awnings. Some were supported by rods, and columns, while other steel and concrete canopies were cantilevered without visible support. They were made of steel, aluminum, concrete or wood. These canopies provided sun screening and also a location for individual letter signs, attached either above, or suspended below the canopy. Although most canopies were rectilinear, some incorporated sweeping curves.

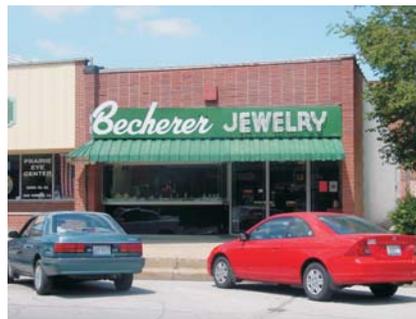
Some storefronts were shaded by fixed aluminum awnings.

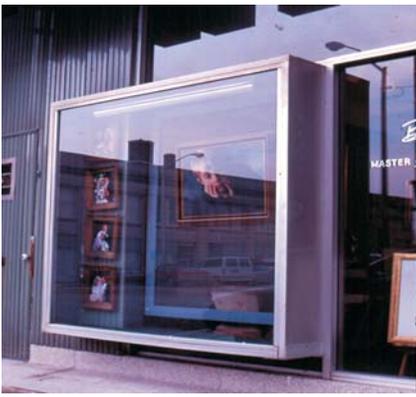
Picture-framed display boxes showcased the latest goods and turned the display window into a work of art. Sleek aluminum or steel surrounded smooth plate glass surfaces. Here a large projecting picture frame is especially suited to this photography studio.

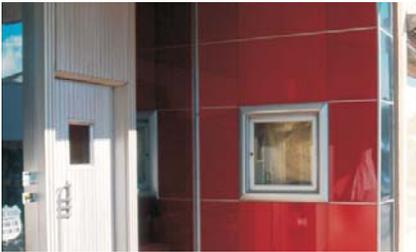
Other picture-framed display boxes were inset into the front or side walls of the storefront. Sometimes, as was in this case, the exterior lobby "accent wall" would continue into the store with more inset displays.

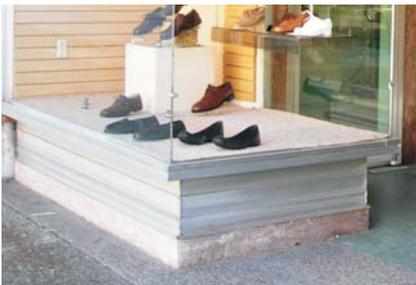
Cantilevered display windows projected beyond their base to further deconstruct the storefront plane. By recessing the base, the display seemed to float, and the exterior lobby felt more spacious.

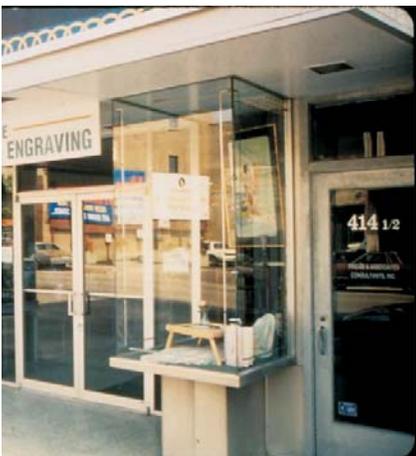
Other cantilevered display cases boxes were mounted on walls and freestanding on three walls.

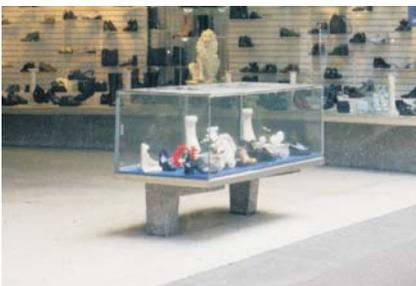
Freestanding display cases were well suited to shoe stores. The smaller goods were brought out beyond the storefront lobby to the sidewalk.

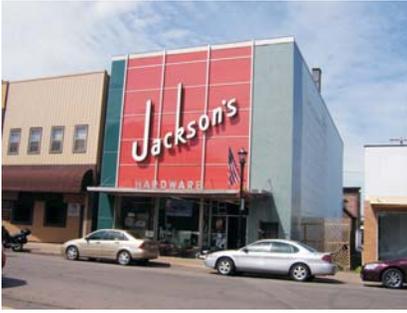
As upper floors often went unused the whole facade sometimes became an advertising “billboard” for the store. Giant signage proclaimed the name and was easily readable by a new fast-moving, driving customer-base.

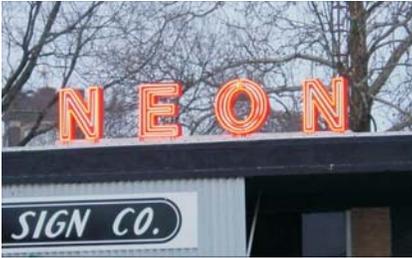
Channel-set neon tubing was set within metal letters with the neon tubes left uncovered and visible. Since the 1970’s most new channel-set letters had their neon hidden by a cover of translucent plastic.

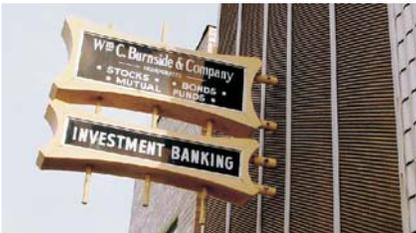
Internally illuminated back-lit use a metal box to hold a light source (either fluorescent or white neon) that is covered by a translucent plastic or glass face onto which graphics were printed. New internally illuminated plastic signs are generally not recommended for historic districts; however, some internally illuminated plastic signs may be old enough or integral enough to the building design or business to consider their preservation.

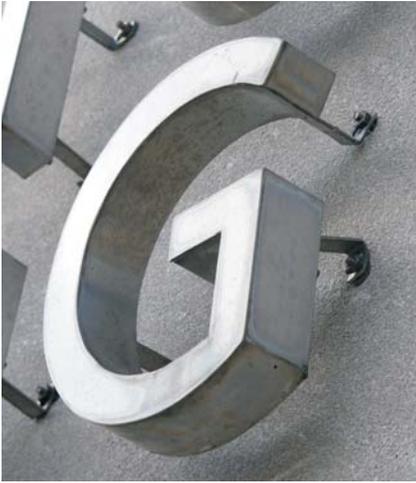
Individual letters were available in a variety of mid-century clean-lined scripts. Made out of stainless steel, painted sheet metal, aluminum or bronze, they were usually pinned to the wall or mounted to a canopy or

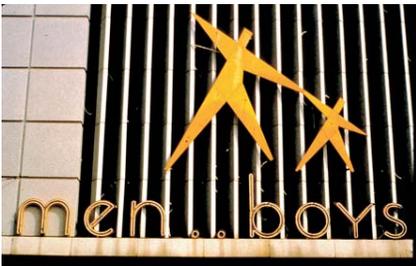
These porcelain enamel letters with channel-set neon are also individual outline letters.

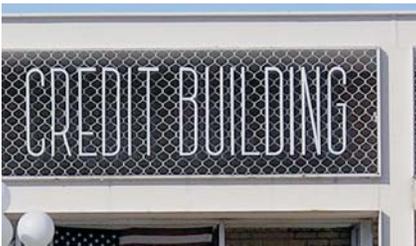
These elongated letters are mounted to a screen above the storefront

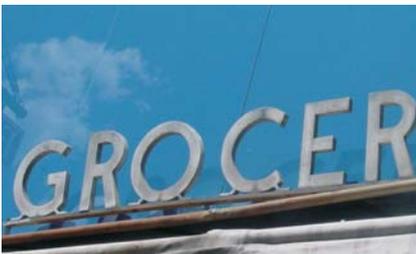
Here, base-mounted lettering stands on a projecting canopy. Others on Main Street were hung pendant-like below canopies.

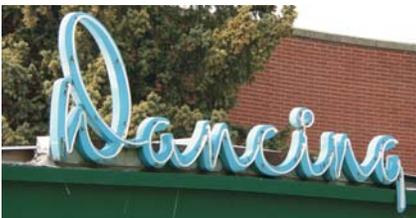
Dramatic script fonts were also utilized for neon and signs in the period.

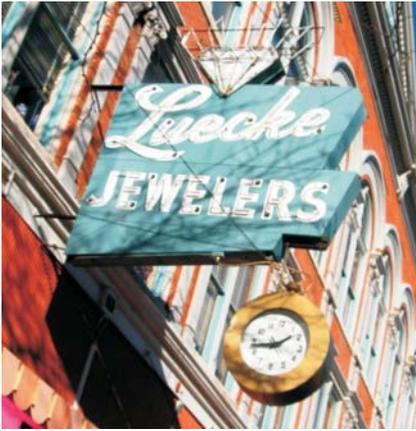
Projecting signs were mounted above the sidewalk and perpendicular to the building facade and were usually suspended from a decorative bracket.

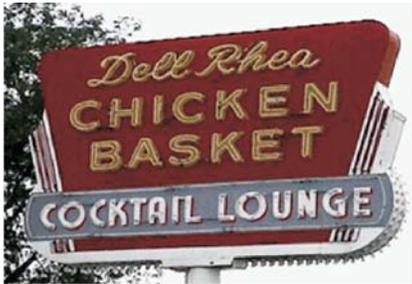
Post signs were more commonly associated with buildings set back from the street or in a more suburban setting. The Dell Rhea Chicken Basket in suburban Chicago is listed on the National Register of Historic Places due to its association with Route 66.

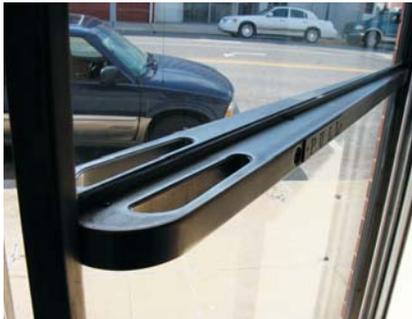
These sculptural door handles decorate this clear bank door.

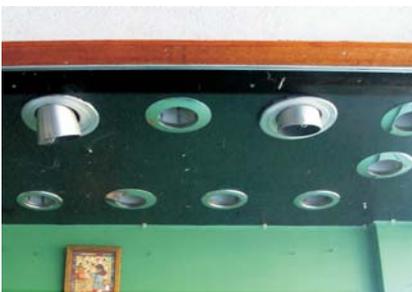
Recessed lighting was utilized in display windows to offset the glare from sunlight and to provide night exposure.

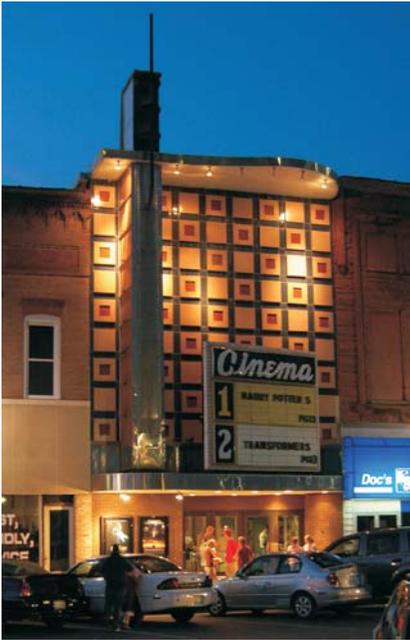
This handsome theater in Taylorville, Illinois is still showing movies. The front facade combine an open lobby topped by a curvilinear stainless steel canopy, a polychrome porcelain terra cotta upper facade and a dramatic porcelain enamel pylon sign. Another curvilinear canopy sits atop the facade, and its curve reverses the lower one. Recessed lighting illuminates the lobby, and upper lighting emphasizes the terra cotta. Other buildings also had structural glass, porcelain enamel facades, or screen slipcovers as below.

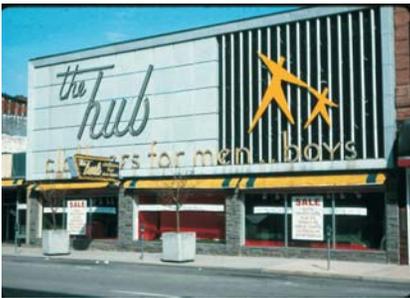
Porcelain enamel was utilized frequently on storefronts. The Hub store had a granite-faced porcelain enamel slipcover and porcelain enamel signs. The Hub facade was demolished to create a new facade that looked "old."

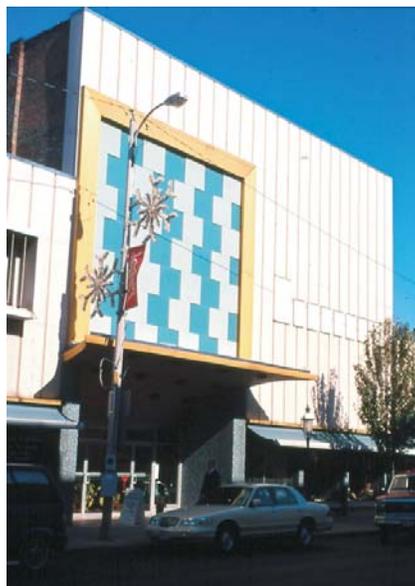
This multi-color porcelain enamel slipcover turned a Belleville, Illinois department store into a dramatic focal point for downtown. Although the original sign is has been painted over, the facade is still striking.

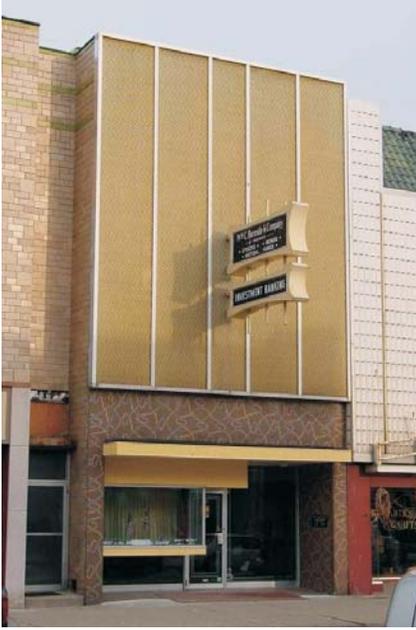
This storefront in Danville, Illinois is in great condition, and has it all. Gold anodized slipcover, projecting backlit sign, tile transom area and side piers, a cantilevered projecting display case, an asymmetrical shopfront, and a projecting canopy. This well-designed and completely intact storefront, makes this building a very significant example of mid-century commercial design. This storefront clearly exemplifies *The Secretary of the Interior's Standards for Rehabilitation*, "Number 3: Most properties change over time; those changes that have acquired historic significance in their own right shall be retained and preserved."

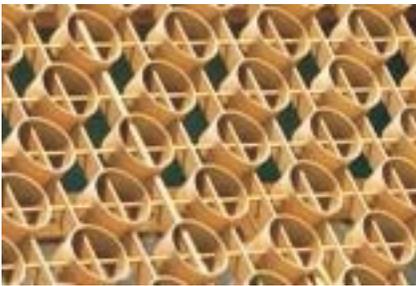
Not all striking modern facades of the mid-century were slipcovers over earlier buildings. Many stores were built in the 1950's. New construction and slipcovers alike could be covered with opaque materials of glass, steel, aluminum or porcelain enamel, or with perforated metal screens that let in sunlight to upper floors. The screens were usually anodized aluminum and were made in a variety of colors.

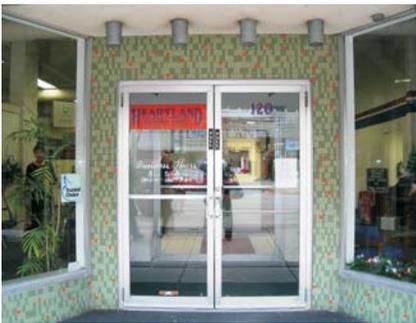
Aluminum, stainless steel, bronze, copper, brass, monel and nickel silver were utilized on storefronts during the mid-twentieth century. After WWII aluminum and steel were the primary materials.

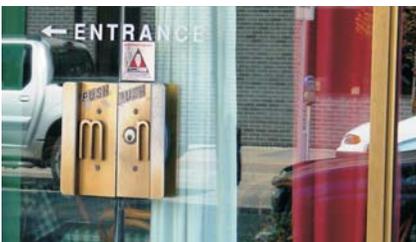
Gold anodized aluminum was less common than clear anodized aluminum, but still quite popular on main street. Anodized aluminum also came in a Champagne finish, both light and dark, and also several other colors. Dark bronze anodized aluminum did not become widely popular

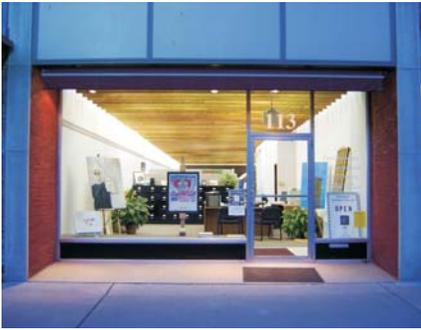
The “open front” utilized large sheets of plate glass to open up the interior store to the sidewalk. Perfectly flat and polished, plate glass provided completely clear views into the store. Plate glass could come in pieces as large as 10’ by 24.’ Traditional plate glass is no longer made in the United

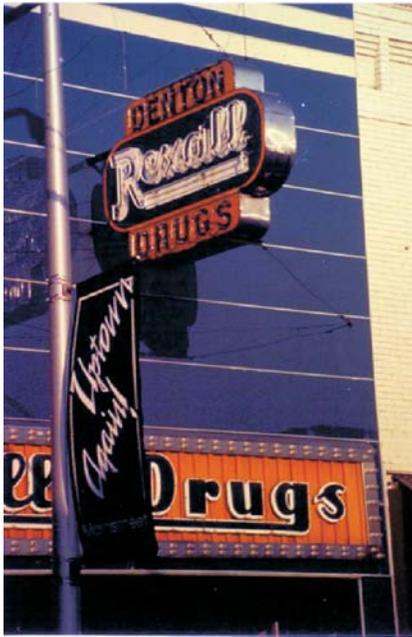
Opaque structural glass was used on storefronts beginning in the first decade of the 20th century. Often known by the proprietary names of Vitrolite and Carrara, by 1940 the glass was available in a variety of colors, patterns and finishes. Highly durable and elegant, the glass was popular up until the 1960’s as a glossy way to modernize existing storefronts. The thinness of the glass meant that it could be attached to a variety of substrates with mastic.

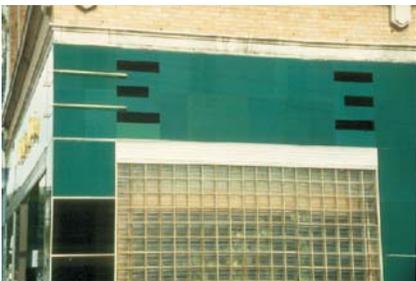
Structural glass contrasted well with aluminum storefronts. Different colors of glass were sometimes used as accents within larger fields of color.

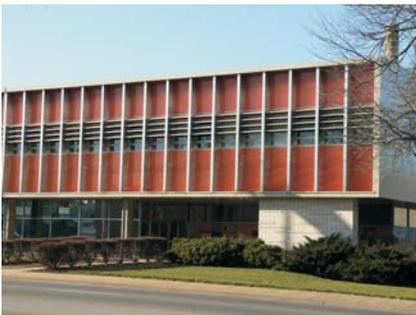
By the 1950’s spandrel glass started to appear in Main Street in curtain walls. These panels were clear glass back-enameled with color.

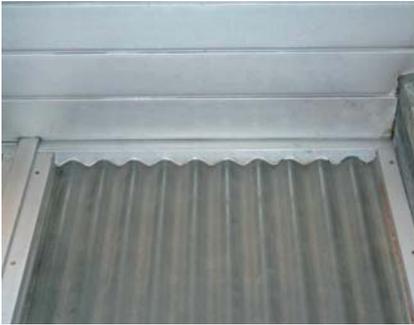
Occasionally corrugated glass was used on main street. Special gaskets and frames that custom-fit the corrugation were marketed by the glass companies.

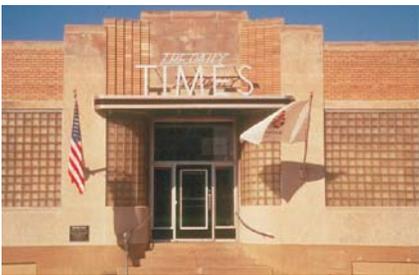
Glass block first appeared on Main Streets in the United States during the 1930's. Although most common during the 30's and 40's, it was still used frequently until the 1960's.

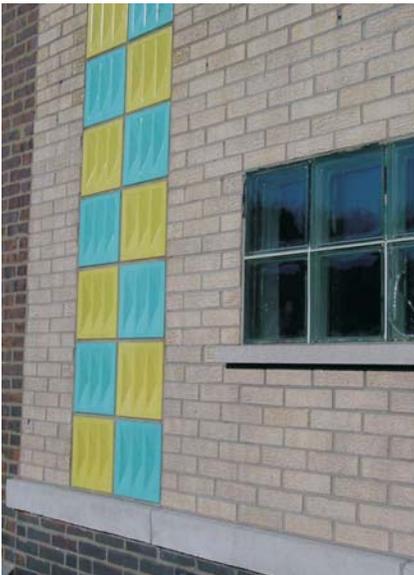
Glass block with colored ceramic frit was used less frequently, but made a dramatic statement when it did appear on main street.

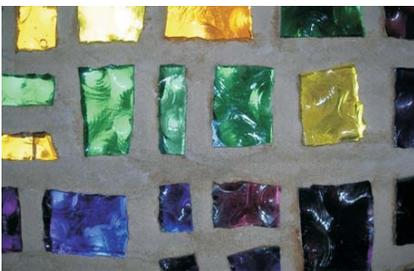
Valle de Verre was colored art glass set in concrete and is occasionally found on main street.

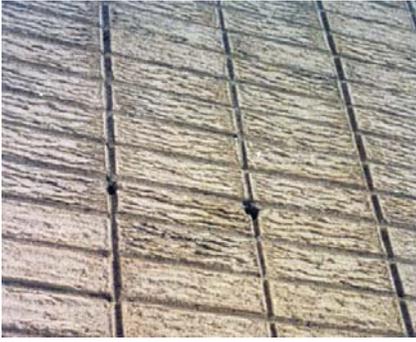
Unusual and textured masonry surfaces were utilized. Often as a contrast to smooth metals and sheets of plate glass. Brick was often stacked in a vertical bond. This provided clean vertical lines for the modern aesthetic.

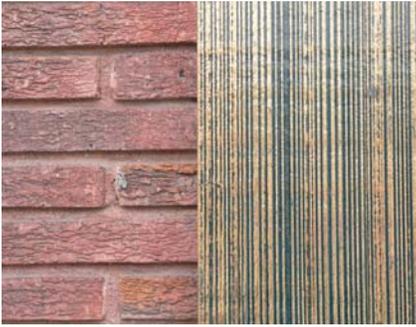
Although used less frequently than brick, stone, or tile, terra cotta was also used on commercial buildings mid-century. This unusual gold-glazed, striated terra cotta is set against highly textured Roman brick, a much more common mid-century material.

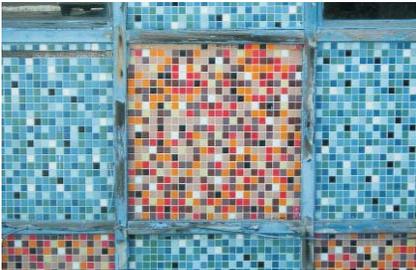
Tile was a popular bulkhead and wall surface. The variety of color and textures could create abstract modernistic patterns. Small tiles in mosaics were most common.

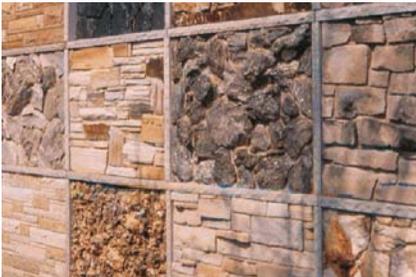
These sample display panels of stone showcased the mid-century possibilities for wall surfaces. The rough-faced veneer was used to provide a more rustic, or suburban look to storefronts.

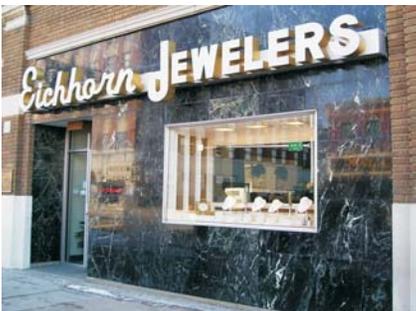
Smooth panels of marble, granite, limestone and other stone served as a more elegant setting for transparent glass and metal lettering. Polished stone projected an expensive image for jewelry stores, banks, or wedding dress shops.

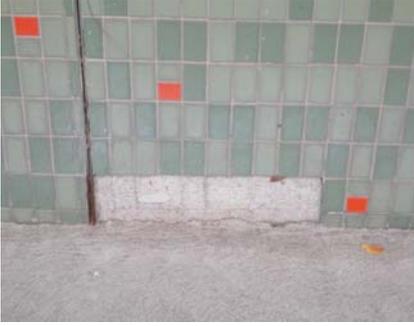
Substitute materials to replicate authentic materials found their way to mid-century storefronts just as terra cotta imitated stone on turn-of-the-century facades. This panel replicates tile pieces, yet there were other panels of materials copying stone, stucco or concrete.

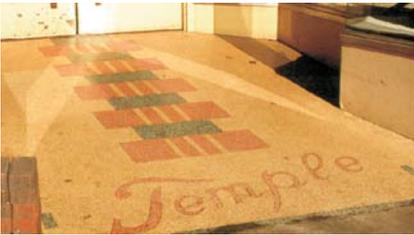
Terrazzo flooring began to be used downtown in the first decades of the 20th century. By mid-century, the smooth surfaces and large stylized patterns well matched the designs of the overall storefront. Just as late nineteenth-century vestibule floors would spell out the business name in encaustic tile, by mid-twentieth century, the more durable and easily cleaned terrazzo did so. Tile in a variety of larger sizes and colors was also

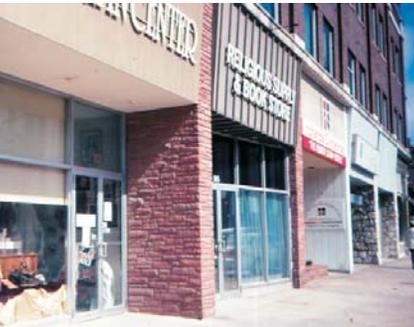
Although some storefronts of the 40's and 50's used woods and rough-faced stone to achieve a relaxed, casual and "suburban" look, those materials became even more popular in the mid 1960's when a more natural look was often favored.

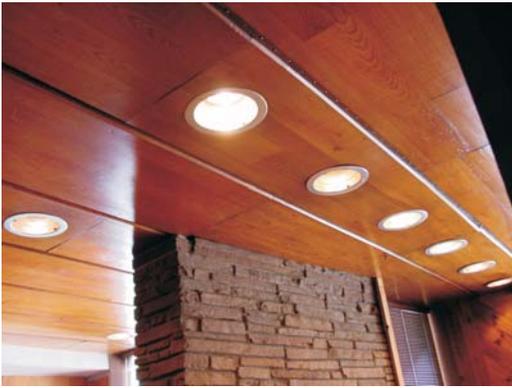
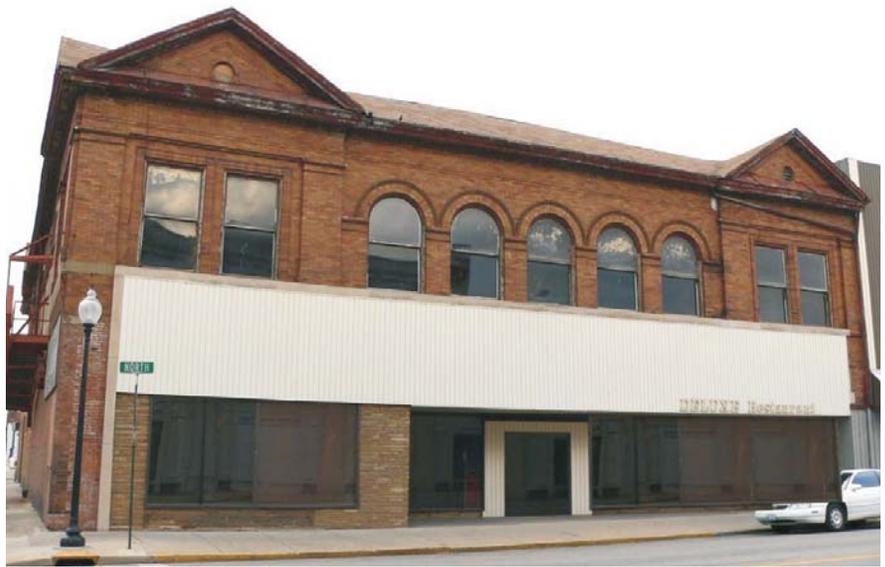
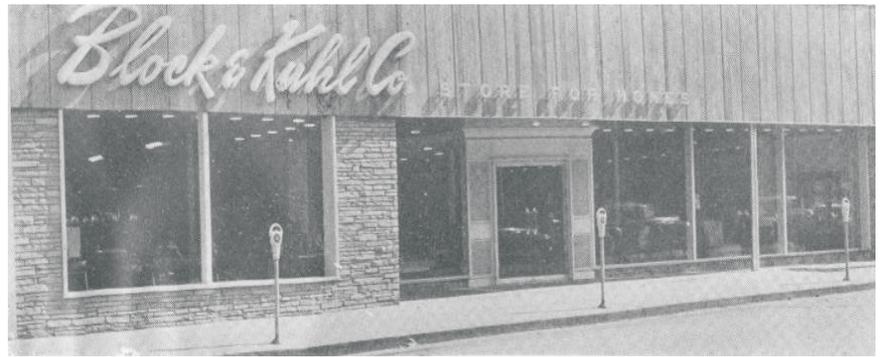
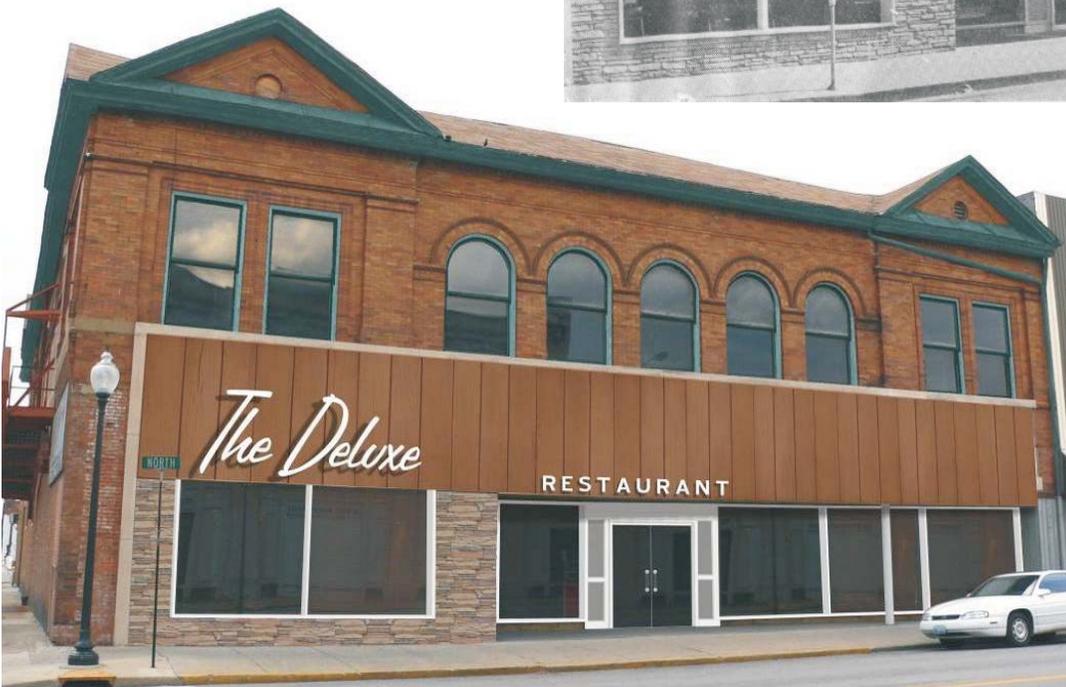
The former Block & Kuhl Furniture Home Store shopfront was designed by the famous designer Raymond Loewy and Associates in 1947. IHPA staff consulted with the Main Street Manager and the owner to explain the significance of the storefront, and created this design. The proposal is to remove the artificial siding over the wooden transoms, and restore the historic 1947 entrance. The sign picks up on the character of the historic sign. The existing interior of the first floor still reflects the Loewy design as shown by the photo of the inside storefront on the upper left. Overall this storefront is very intact. For more information and to view an archive of IHPA Main Street facade designs for mid-century storefronts go to: [Http://www.illinois-history.gov/ps/midcentury.htm](http://www.illinois-history.gov/ps/midcentury.htm).

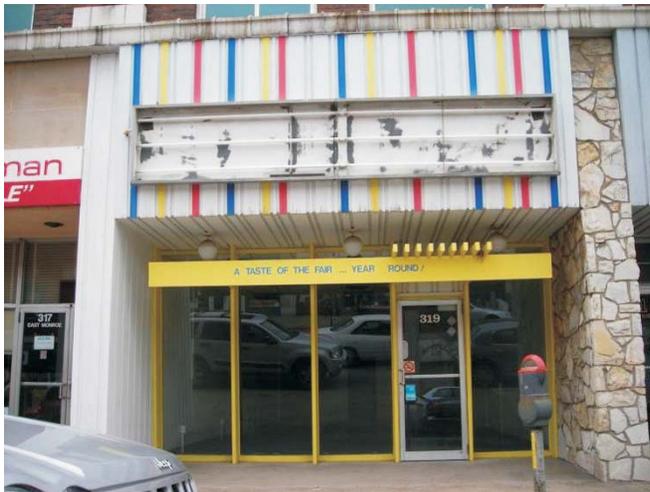
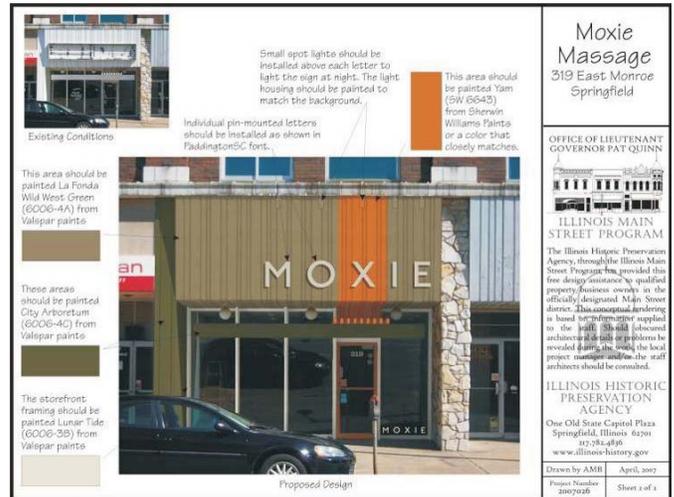
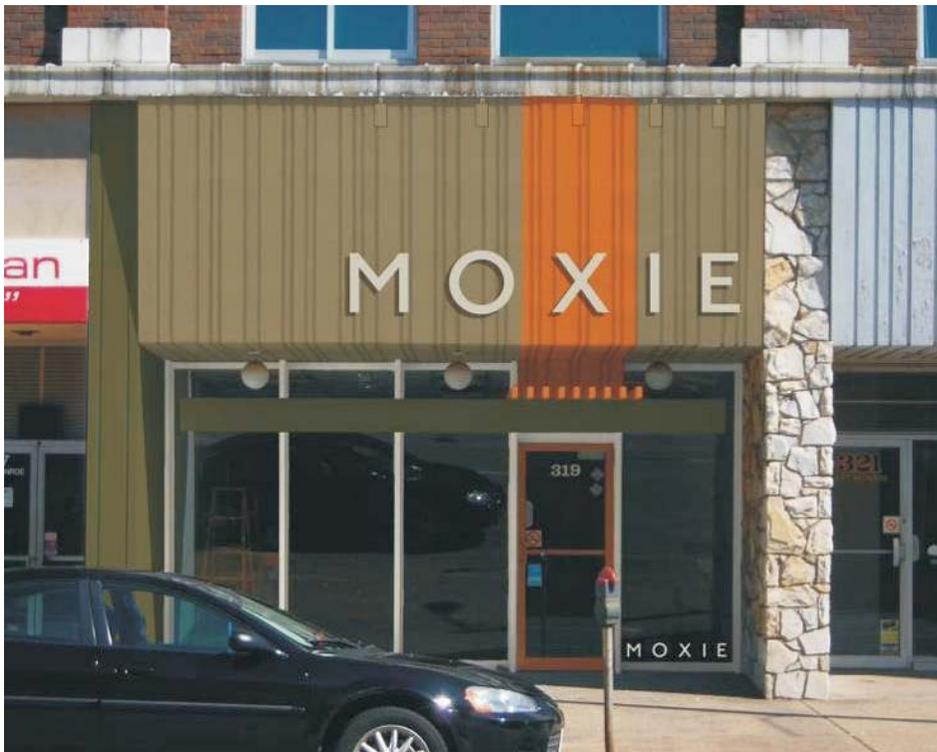
This rustic modern storefront is part of a series of 1960's ground-floor alterations of an late nineteenth century building. The original wood siding and trellis had been painted primary colors by a previous owner. The original stone veneer wall remained unpainted. The damaged, internally-lit plastic sign was not original to the design. When a new business moved into this storefront they wanted a completely new look . Anna Margaret Barris designed this paint scheme in more natural tones. She recommended preserving and highlighting the horizontal trellis above the door, and retaining and restoring the original globe light fixtures. The design incorporated strong colors to contrast with the light stone and to highlight its texture. The owner now loves their new "old" storefront. This storefront is now the most attractive on this block. For more information and to view the complete archive of IHPA Main Street facade designs go to: <http://www.illinois-history.gov/PS/mainstreet.htm>.
