LOOKING AT HISTORIC WINDOWS

WOOD WINDOWS: REPAIR OR REPLACE?

Sound familiar? The issue of what to do with wood windows in older buildings is a question that frequently confronts owners, developers, facility managers, tenant boards, and design professionals who are charged with making decisions relative to historic properties. Here, a seasoned window consultant discusses the repair-vs.-replace conundrum — illustrated by a real-world case study.

by Michael P. Fishman, *President, Historic Window Resources, Inc.*

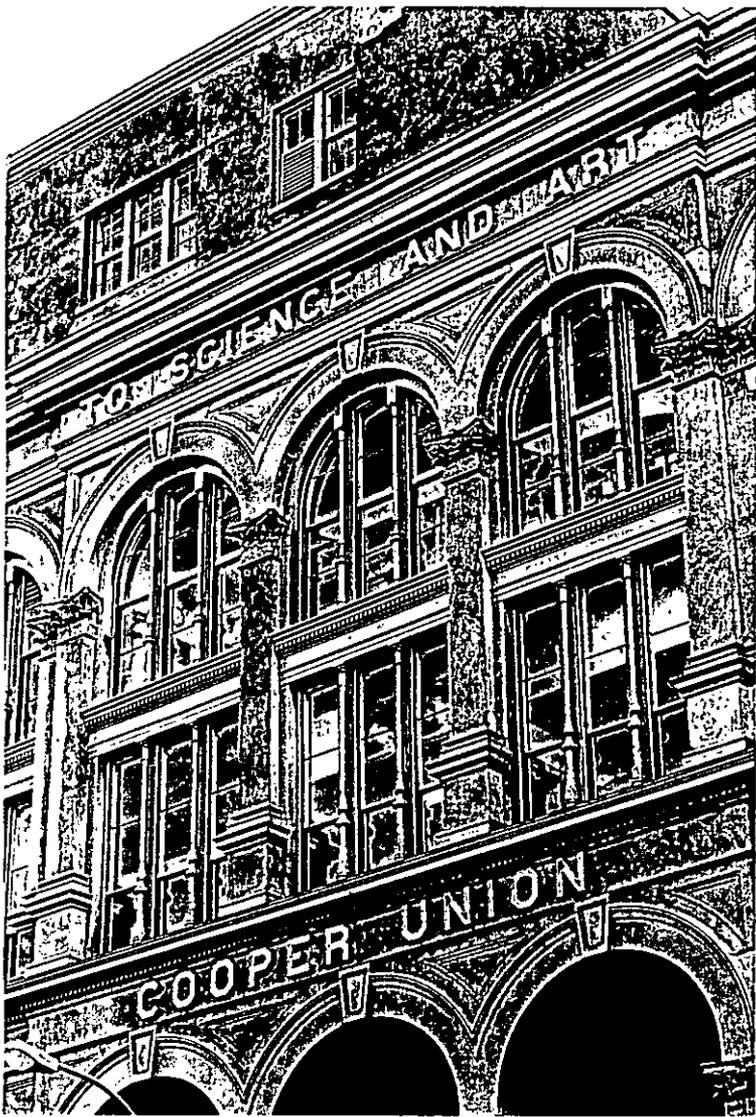
The North elevation of a restored Cooper Union shows the restored windows with fixed pivot sashes; replaced exterior casings, sills, and double hung windows; and a copper spandrel panel between floors.

The most distinctive feature of Frederick A. Peterson's original Italianate design was Cooper Union's monumental Romanesque Revival windows. These openings consist of weights-and-chains double-hung windows, assembled in mullions, with horizontal-pivot windows that are centered at the head of each mullion and flanked by fixed trefoil sash. These units form the upper portion of the building's predominant window openings, and are mullied over a pair of mullioned double hungs to create a 30-ft.-tall bay. A copper spandrel panel separates the double-hung windows between floors. (See photograph at left.)

After much discussion with the design team, it was agreed to recommend to The Cooper Union a course of action where the decorative window heads would be repaired; the pivot sashes would be made fixed; and all exterior casings, sills, and double-hung windows would be replaced. Other small horizontal-pivot windows were also to be restored.

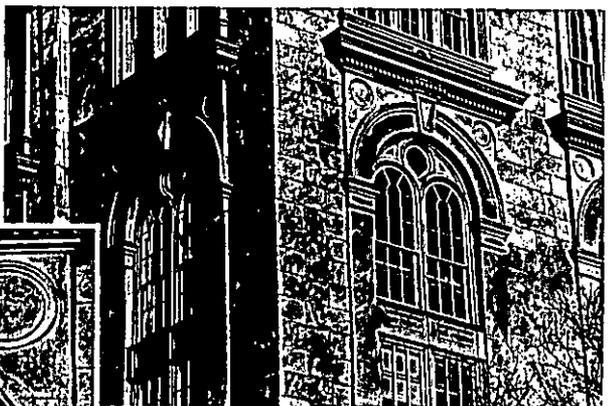
The restored South elevation of Cooper Union after the installation of the new windows.

The end result is that Cooper Union's windows have been restored to their original appearance, non-conforming alterations have been removed, and this building will continue to please the eye for generations to come.

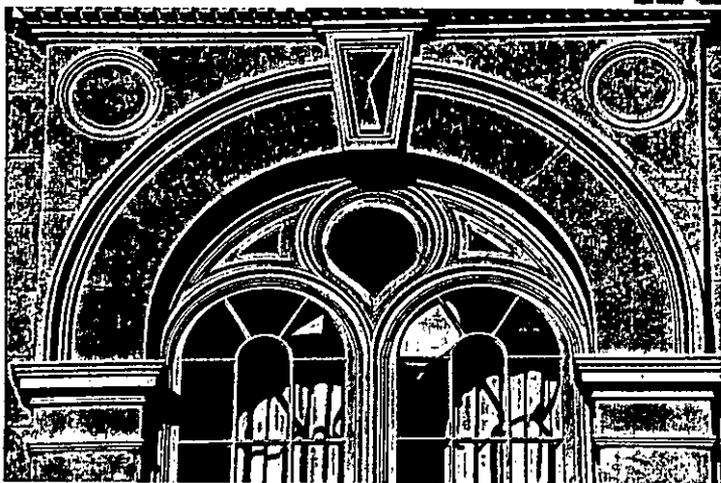
During the Cooper Union window restoration, horizontal pivots were made fixed and trefoils were repaired.

This decision was based on the realization that there was significant sash deterioration; attempts had been made to repair the double-hung sashes on other occasions with unsuccessful results, profiles were inconsistent, and the institution wanted a lasting solution to the window issue. Honduras mahogany was designated as the approved species, and Dahlgrens, Inc., of Oglesby, Ill., manufacturers of Replica Windows, was selected to build the new units. The design team selected one of the original sticking profiles to act as the standard for the new windows. Dahlgrens successfully engineered slip-in windows that were installed within the original weight boxes, thus eliminating the need to perform major interior demolition to set the windows. Upper sashes were made fixed to reduce costs, but were engineered to be moveable for future painting or other maintenance.
