WASHINGTON STATE PARKS ARCHITECTURE

1943–1985

PREPARED BY
NORTHWEST VERNACULAR, INC.

Washington State Parks and Recreation

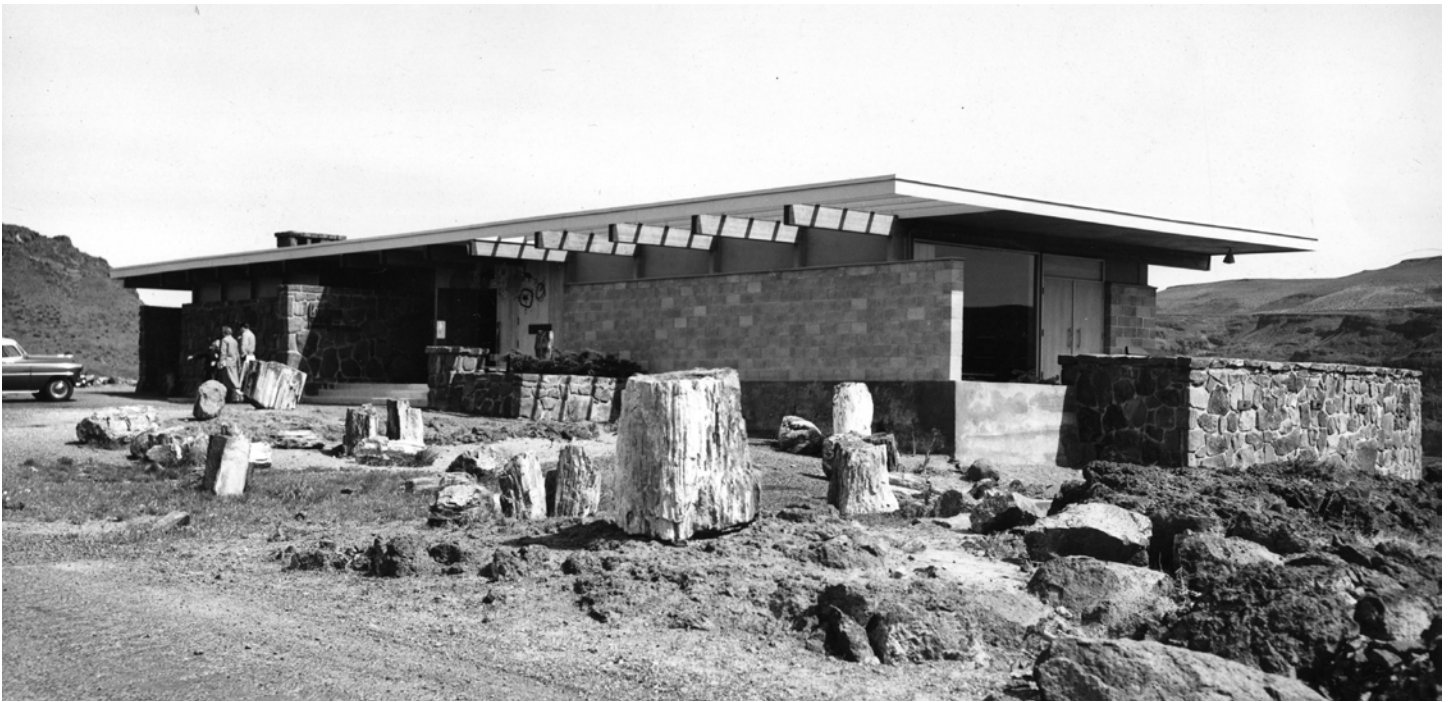
Ginkgo Petrified Forest Interpretive Center, ca. 1955. Photographed by James S. Rayner. General Subjects Photograph Collection, 1845-2005. Courtesy Washington State Archives.

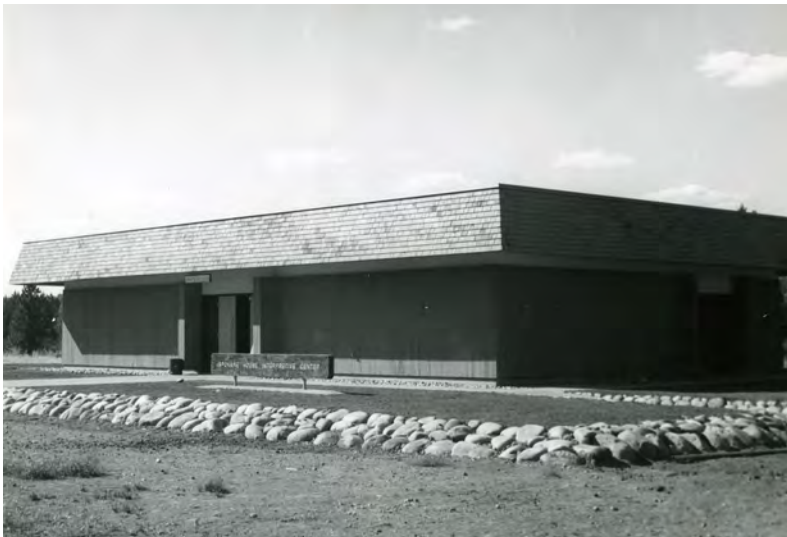
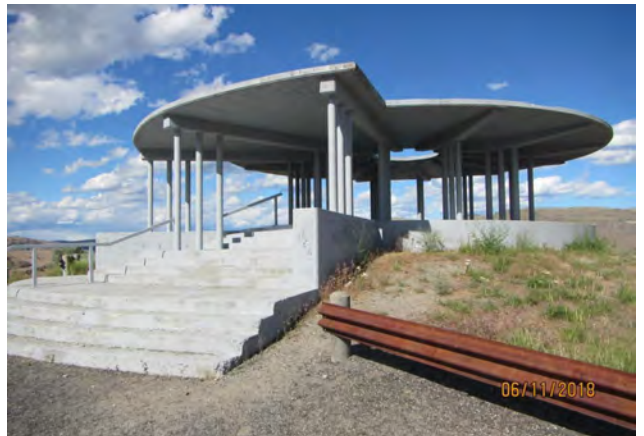
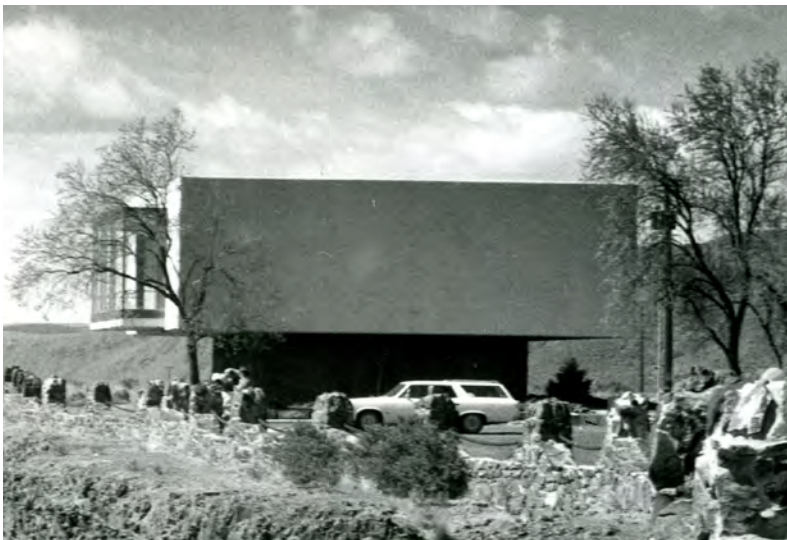
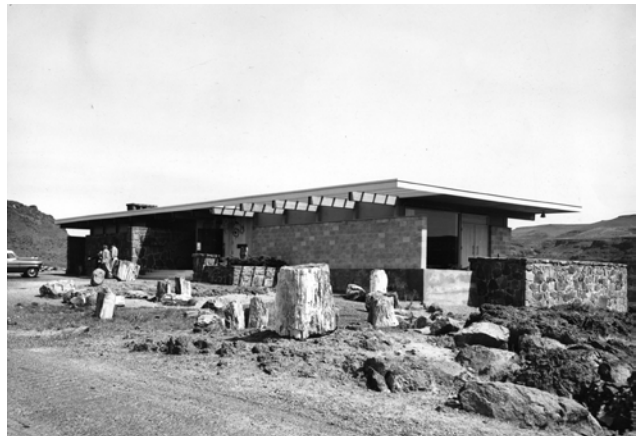
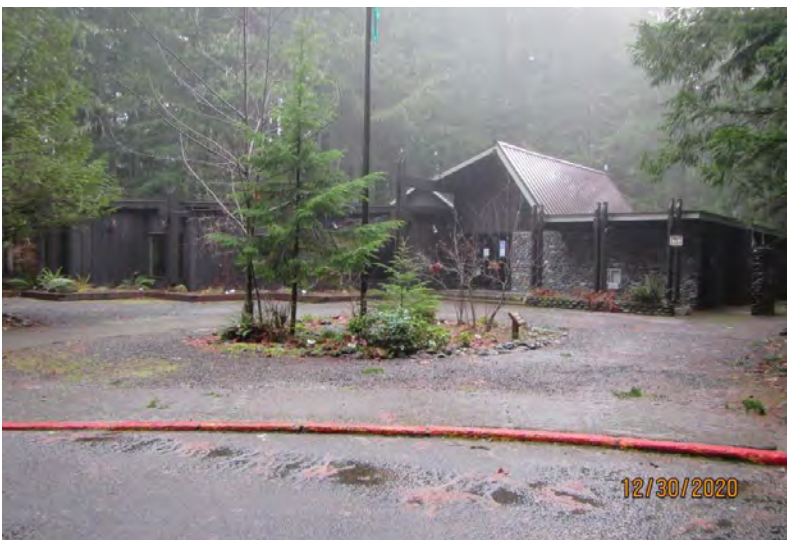
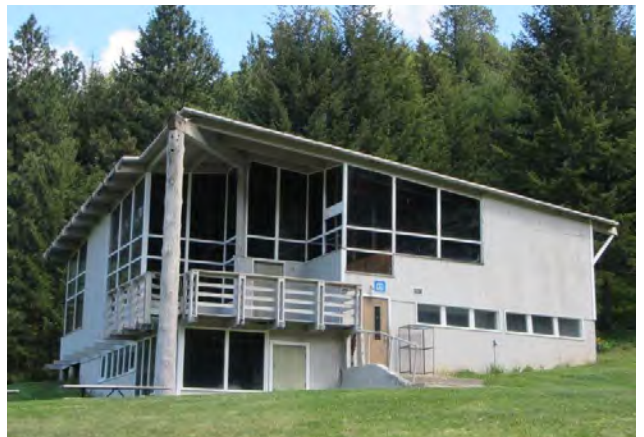
Counterclockwise from upper right: Crown Point Vista Dome; Ginkgo Petrified Forest Interpretive Center; Squilchuck Ski Lodge; Palouse Falls Vista House; Federation Forest Interpretive Center; Sun Lake-Dry Falls Interpretive Center; and Spokane House Museum. Courtesy Washington State Archives and Washington State Parks.

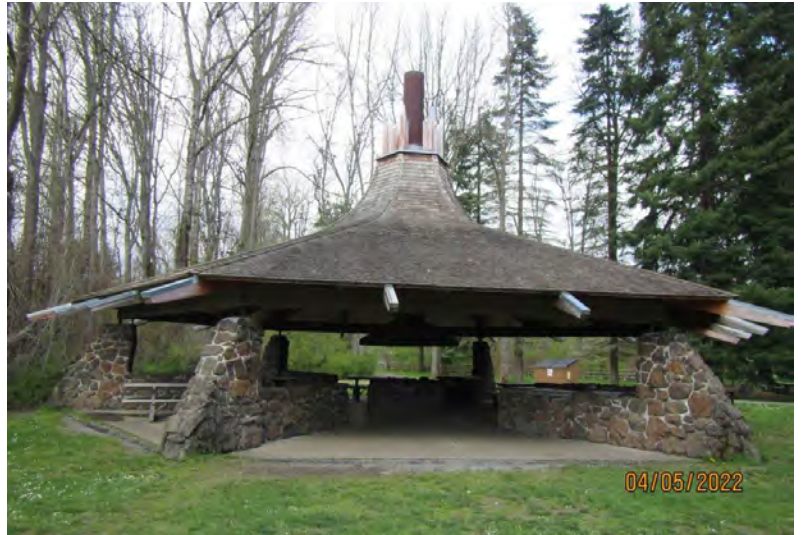
Lake Sammamish State Park, kitchen shelter, 2022. Courtesy Washington State Parks.

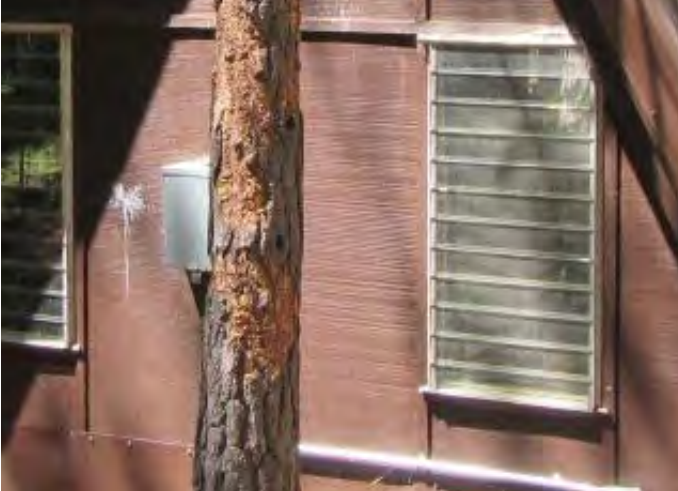
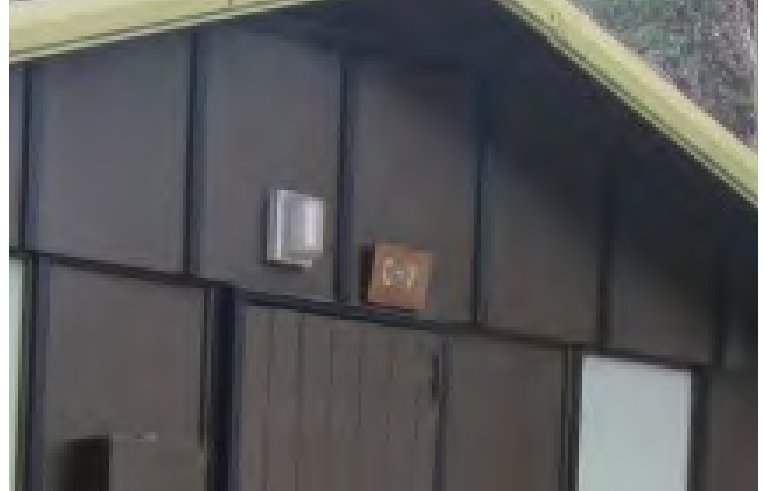
Plywood. Building 25 (1964), Brooks Memorial clad with plywood (left) and building 107 (1951), ELC Camp Wooten (right).

Plywood. Plywood is an engineered wood product made of an odd number of thin veneers (or plies) placed so the grain of one ply is at right angles to the next. This cross lamination creates strength along and across the resulting plywood panel. Plywood was originally used for door panels and drawer bottoms. In 1934, the use of waterproof adhesives in plywood manufacturing allowed new applications for boats and exterior siding.⁶¹

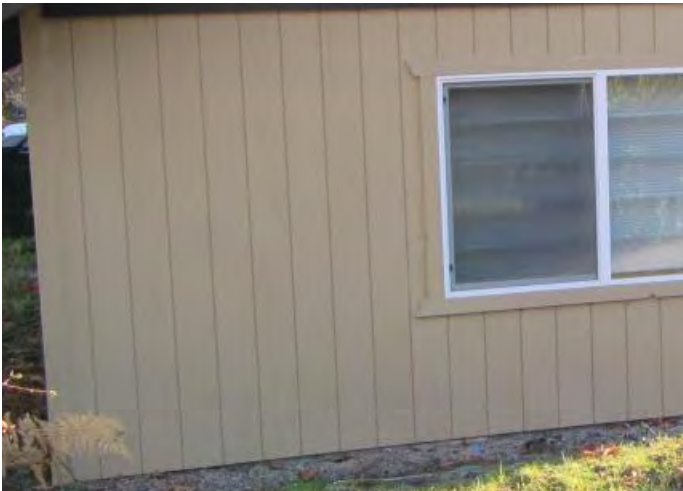
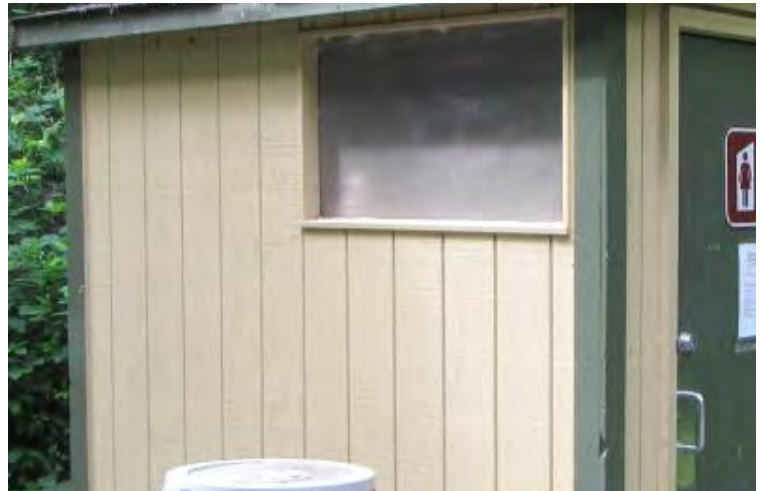
T1-11. Building 10 (1975), Kopachuck (left) and building 22 (1960), Dosewallips (right).

T1-11. T1-11 is a grooved plywood siding that is manufactured in sheets. It was a popular siding material during the mid-20th century.

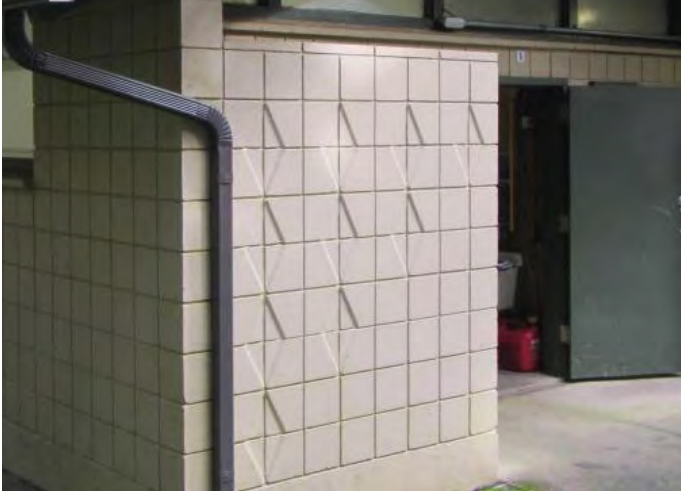
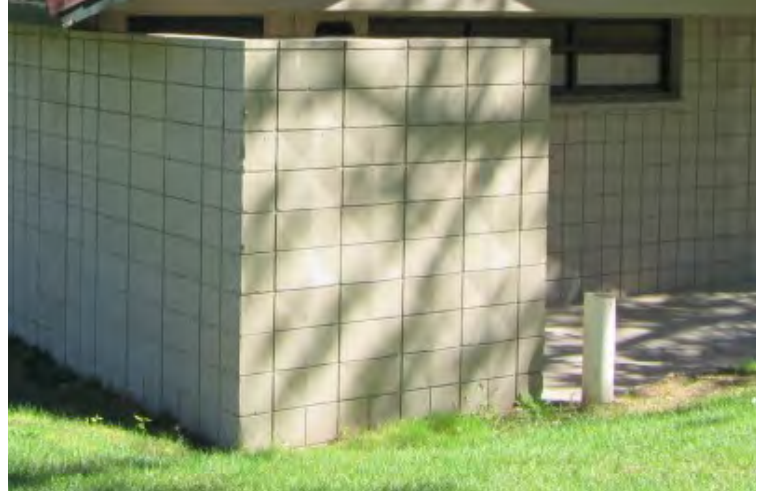
Shadow block. Decorative concrete blocks (concrete masonry unit or CMU) emerged in the 1950s after aggressive marketing efforts by the concrete block industry and technological advances were made in their production. Previously seen as largely utilitarian for foundations and industrial buildings and called “cinder blocks,” concrete blocks gained popularity as a decorative accent in the mid-1950s. The National Concrete Masonry Association advertised the ability of concrete blocks to provide economic and aesthetic value in new construction. Shadow block is a concrete masonry unit that has a shaped face to create patterns of light and dark (or shadows) on its surface. Screen or breeze blocks are concrete blocks with an open design that creates a wall that can provide ventilation, partial shading, privacy and/or a decorative surface.

Shadow block. Building 10 (1960), Bogachiel (left) showing recessed shadow block and building 1 (1983), Bridgeport (right) showing raised shadow block.

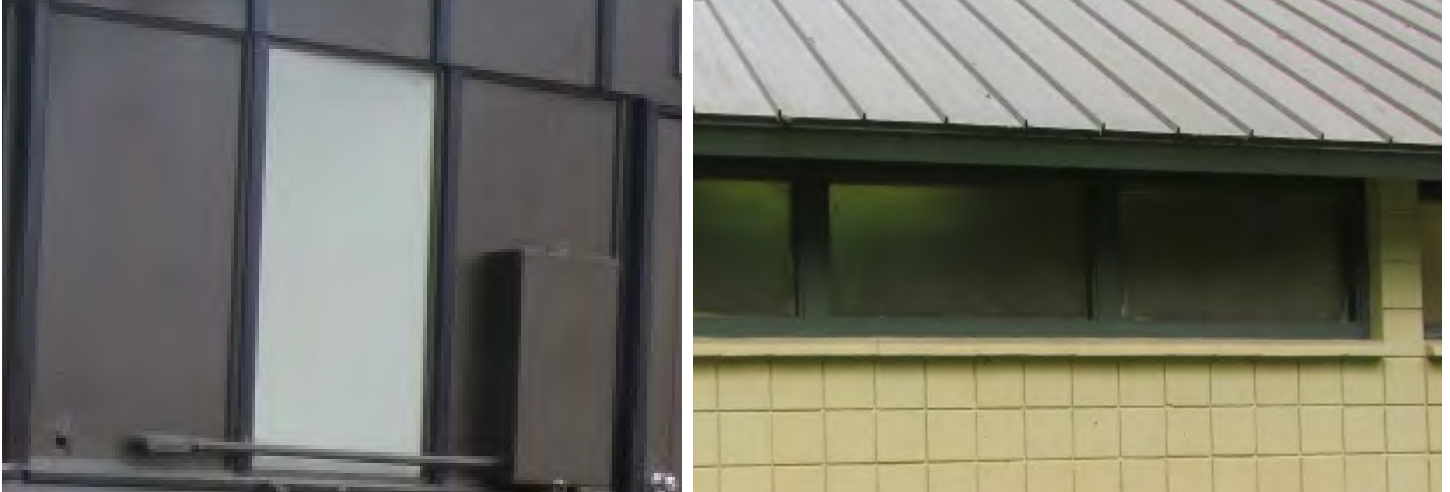
Plastic. Building 107 (1951), ELC Camp Wooten (left) and building 6 (1961), Deception Pass (right).

Plastic. Plastic emerged in popularity in the 1950s, from furniture and building materials to many other consumer products. Plastic was used in windows, countertops, and flooring.⁶²

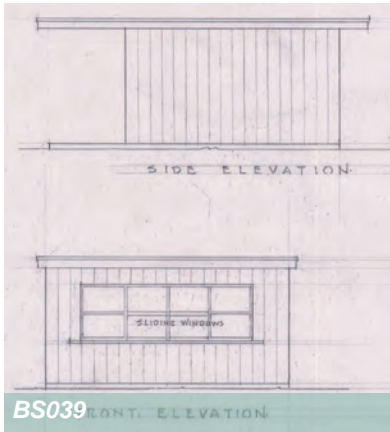
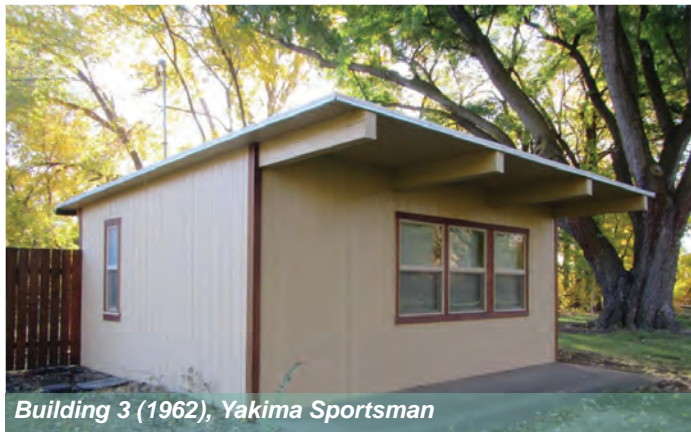
BS039 Concession Building (1961)

Variations included six floor plan options based around single, double, and triple service counter layouts. This design is used at Yakima Sportsman.

The designs did not specify a foundation type. The designs did not specify cladding for the platform frame structure, but the drawings indicate T1-11 or similar vertical siding.

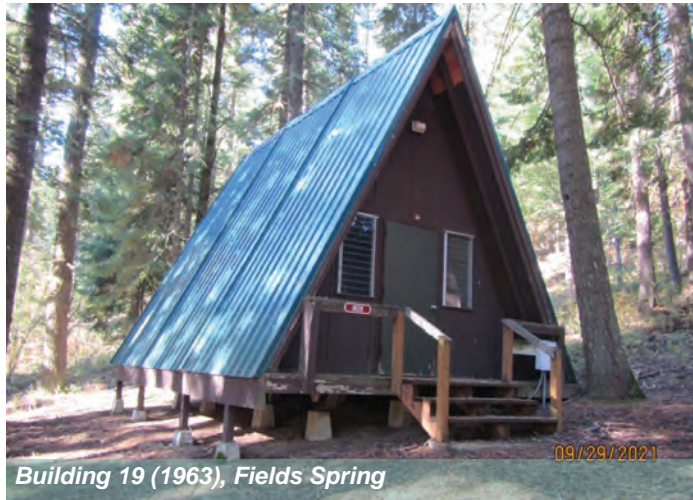
BS031 8 Man Squad Hut (1963, oldest resource)

Buildings built as early as 1963 (Fields Spring, buildings 18 and 19) pre-date this base design indicating an earlier base design. Examples of this standard plan were built through 1968. This design is used at Brooks Memorial, Fields Spring, and Moran.

A post and concrete pier foundation supports the platform frame structure. Side walls (roof) feature projecting paired 2-by-6-inch rafters on 8 foot centers dividing the side walls into three bays. Galvanized iron caps these projecting rafters. Plywood (redwood, 3/8 inch thick) with battens clads the end walls (gable ends) of the building. Insect screen vents occur at the peaks of the end walls.

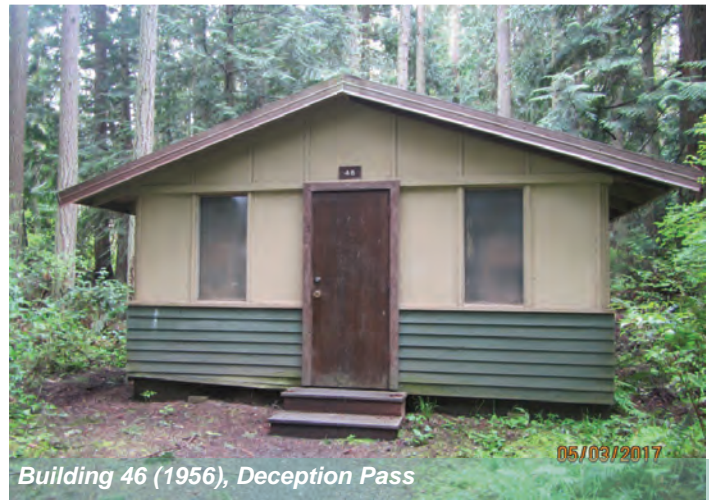
BS032-1 Standard Squad Hut Group Camp Facilities (1950, oldest resource)

Buildings built as early as 1950 (ELC Camp Wooten, buildings 11 and 12) pre-date this base design indicating an earlier base design. Examples of this standard plan were built through 1964. This design was used at Brooks Memorial, Deception Pass, ELC Camp Wooten, Millersylvania, and Moran.

- BS032-3 Standard Cook's Quarters Group Camp Facilities (ca. 1956), utilizes the same design as BS032-1, with the interior layout changed to provide two living units. An interior vestibule off the main entrance has doorways opening to each living unit. Within the building there is a central bathroom (single toilet and shower) with doors opening to each of the living units. The April 11, 1960, revisions provided a concrete foundation and floor option. There is one extant building that uses this design and was built in 1956 (Millersylvania, building 31).
- Corner boards at horizontal siding is evident on some and appear to have been original construction. At least one variation built in 1960 utilizes clapboard in the gable end (Moran, building 40)

A post and pier (concrete block) foundation supports the platform frame structure with 4-by-8-inch beams spanning the posts and carrying the 2-by-6-inch tongue-and-groove decking. Cedar siding (1 by 6 inch) clads the lower portion of the building, with a wood cap along the top of the siding. Plywood clads the upper wall portion, with panels recessed between the vertical 2-by-4-inch stud framing. Wood louvered vents are located at the peaks of each gable end.

Internal organization consists of an open floor plan. Plywood clads the lower walls on the interior. The January 16, 1961, revisions provided a layout consisting of a front administration office off the entrance doorway separated from sleeping quarters and a toilet room by a plywood-clad partition.

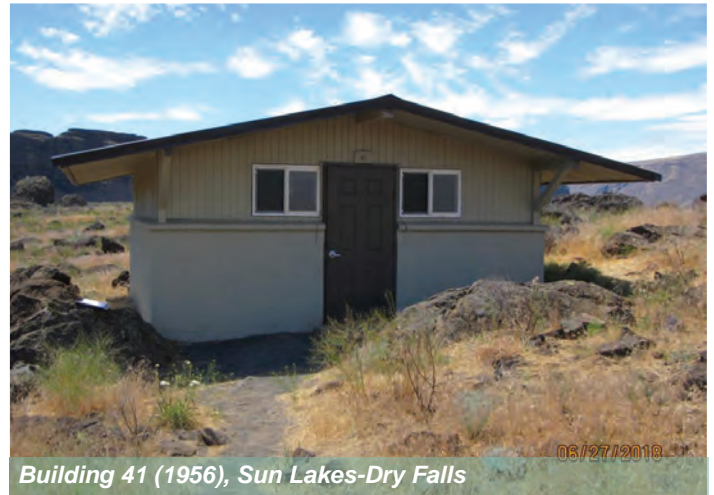
BS032-2 Squad Huts (1956, oldest resource)

Buildings built at Sun Lakes-Dry Falls utilize this design and date back to at least 1956 based on Excel inventory data, indicating an earlier base design, since the buildings match the design but were built prior to the date recorded on the drawing. This design was used only at Sun Lakes-Dry Falls.

A concrete foundation supports the concrete block and platform frame structure. Concrete blocks are 8 by 8 by 16 inches, laid up in a running bond with a projecting concrete block cap that transitions to the upper wood frame wall portion. Wood frame portions are clad with T1-11 siding with the horizontally run channels.

Internal organization consists of a single open volume for sleeping.

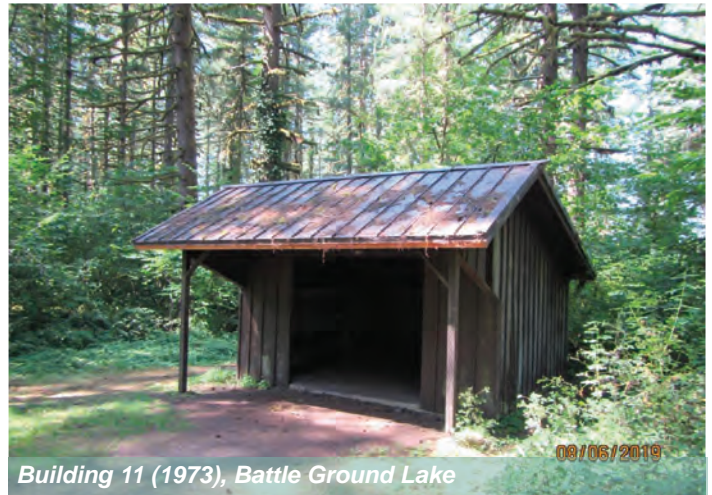
BS111 8 Person Adirondack Shelter (1969)

This design remained in use through at least 1982. This design was used at Battle Ground Lake, Blake Island, Green River George (GRG)–Kanaskat-Palmer, Moran, Rockport, Sequim Bay, and Spencer Spit.

- BS111 variation included the use of a concrete slab and foundation rather than a wood floor. This was included as part of the base 1969 design.
- The 1987 BS111 design replaced the 1969 design as of 4/2/1987. The 1987 design added two skylights on the rear slope, changed the double 2-by-4-inch top plates to 4-by-10-inch girders, changed the plywood siding to T1-11 plain face, and extended the crushed rock at the front stoop to the full width of the facade.
- BS111 variation built in 1978 at Moran (building 59) is clad with wood shingles.
- BS112 (1969) was designed at the same time as BS111, but is a smaller 15-by-13-foot variation accommodating just four persons. The design utilizes 1-by-12-inch cedar boards rather than resawn plywood.

Concrete footings support paired 2-by-8-inch girders carrying the platform frame structure with 4-by-4-inch outer posts. Resawn plywood, with 2-inch cedar battens on 12 inch centers, clads the building. All exterior wood has two coats of Olympic Semi-Transparent Stain No. 717.

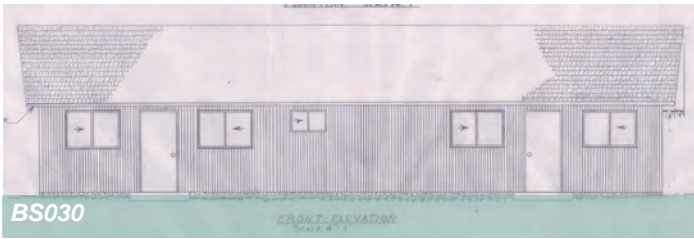
BS030 Group Camp Building (1966)

This design was used at Moran.

A concrete foundation supports the platform frame structure. T1-11 (5/8 inch thick) clads the building with horizontal board siding in the gable ends. Galvanized metal screen vents occur at the gable end peaks.

Fenestration consists of aluminum, horizontal slider windows symmetrically placed on each facade. Window openings feature flush sills, a stool, and rounded 2 1/2-inch interior casings. Bathroom windows have obscure glass. The main entrances are on the front facade, with a separate doorway for each dormitory. Each doorway has a flush-panel wood door with wood casings.

Internal organization consist of open single volume dormitories on either side of central bathrooms. There are two bathrooms, each with two toilets, two sinks, and a shower. Each is accessible only from one connected dormitory via a pocket door. Interior wall and ceiling finishes are plywood.

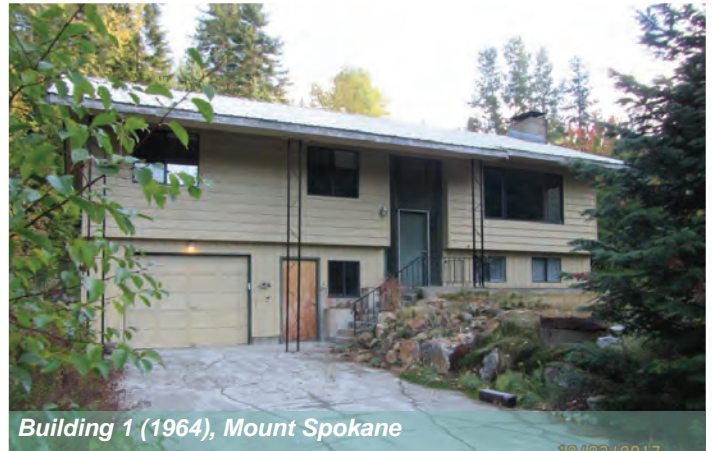
Building 1 (1964), Mount Spokane

This design draws heavily on many of the design features established in 1963 in the BS027 Rangers Residence, but with enough changes in materials, design details, and form to set it apart as its own design rather than a variation of BS027. This design was used at Kopachuck and Mount Spokane.

A concrete foundation supports the platform frame structure. Beveled 10-inch siding laid with an 8-inch exposure and narrow corner moldings clads the building. Vertical siding with an 8-inch exposure and laid with a reversed bat (rough side out) clads the gable ends and the exposed portions of the basement. Wood surfaces were specified to be painted with two coats of Penta stain (5% Pentaerythritol) Cocoa Brown with Mist Green (817 Fuller House paint) at the soffits and trim.

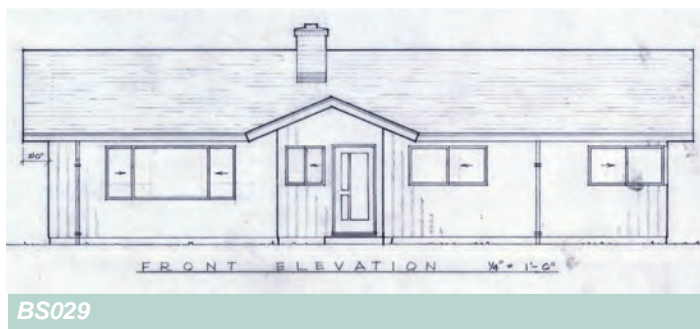
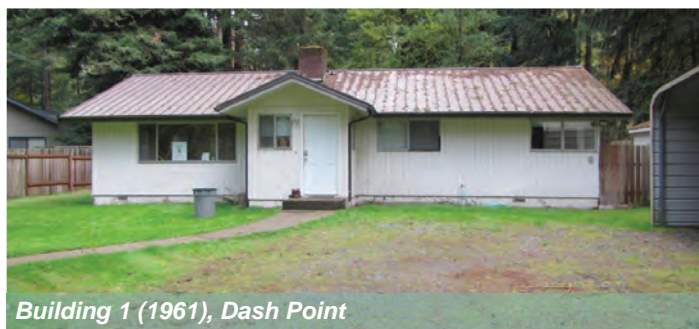
BS029 Park Rangers Residence (1961)

This design was used at Dash Point. Variations in design include the following:

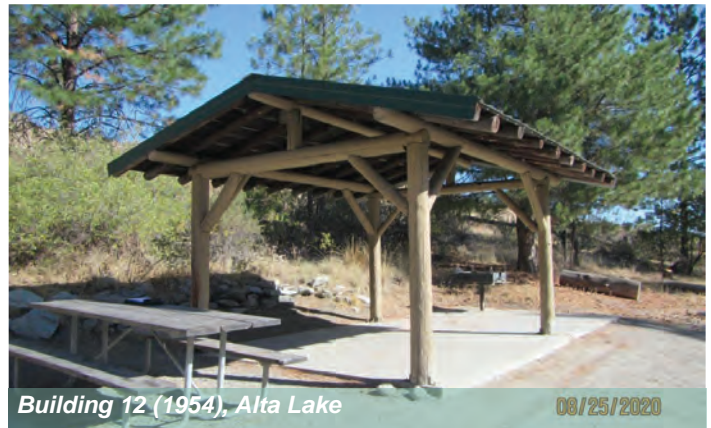
BS038 Cooking Shelter Standard Design (1950, oldest resource)

There is a high level of variety evident in built examples of the BS038 design, with different column and cross brace diameters and slight adjustments made in roof pitch and plan size across examples. The design remained in use through at least 1985 and was used at Alta Lake, Belfair, Birch Bay, Crawford, Dash Point, Dosewallips, ELC–Camp Wooten, Fort Simcoe, Jarrell Cove, Kopachuck, Lake Sammamish, Nolte, Palouse Falls, Penrose Point, Potlatch, Rainbow Falls, Riverside, Rockport, Saltwater, Sequest, South Whidbey, Sucia Island, and Wallace Falls.

A concrete foundation supports the braced frame log structure. Log posts at the outer corners support log cross beams at either end and along the sides. Logs are lapped at corners. Angled log bracing extends between the posts and beams. Short log posts set into notches at the mid-span of the end cross beams carry the center ridge beam.

The building is open on all four sides and does not have windows or doorways. Internal organization consists of a single open interior volume with a concrete floor.

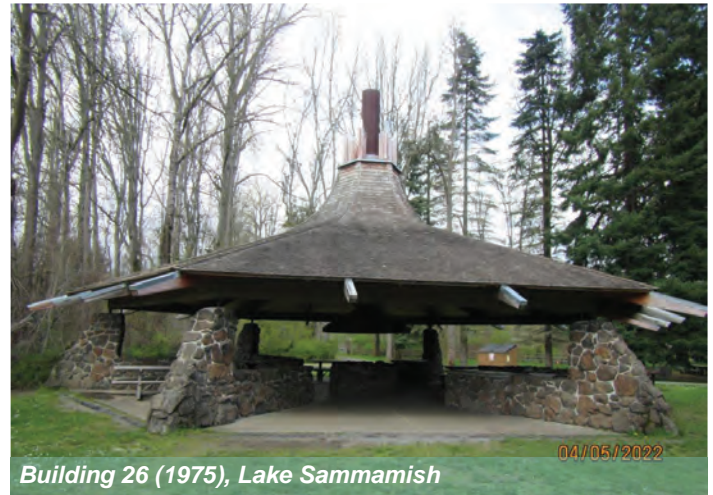
BS104 Kitchen Shelter (1973)

This design was used at Lake Sammamish.

A concrete foundation supports the post and beam structure. Three-inch diameter steel posts are set at the outer ends of each of the six party walls. Concrete buttresses clad with rubble basalt stone enclose the steel posts. Buttresses are battered at the outer face. A 3-foot-tall non-loadbearing rubble stone party wall extends inward from each buttress. Glulam beams (5 1/8 by 15 inch) span around the perimeter of the structure between the posts.

Internal organization consists of a central 7-foot diameter fire pit with a perimeter walkway. Open picnic areas occupy each of the six sides. The party walls separating each have concrete counter tops with stainless steel sinks and metered electric ranges. Flooring consists of exposed aggregate (pea gravel mix) concrete.

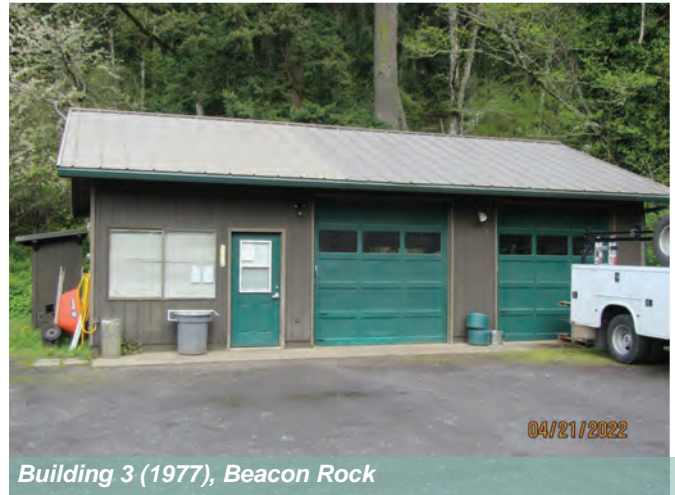
Building 3 (1977), Beacon Rock

There are at least four variations of this design. All were drawn by J. D. Turner. At least one building was built in 1964 (Rockport, building 2), indicating a possible earlier base design based on the extant building predating the drawing date. The design remained in use through at least 1984, and was used at Battle Ground Lake, Bay View, Beacon Rock, Belfair, Fort Ebey, Ginkgo, Jarrell Cove, Kitsap Memorial, Kopachuck, Lake Chelan, Manchester, Maryhill, Nolte, Paradise Point, Rainbow Falls, Rockport, Scenic Beach, Sequim Bay, and Spencer Spit.

A concrete foundation supports the platform frame structure. Horizontal cedar siding (8 inch exposure) with mitered outer corners clads the building.

Internal organization consists of an open interior volume with a toilet room in the back corner. A crane rail is suspended from the roof trusses with double rafters at this location.

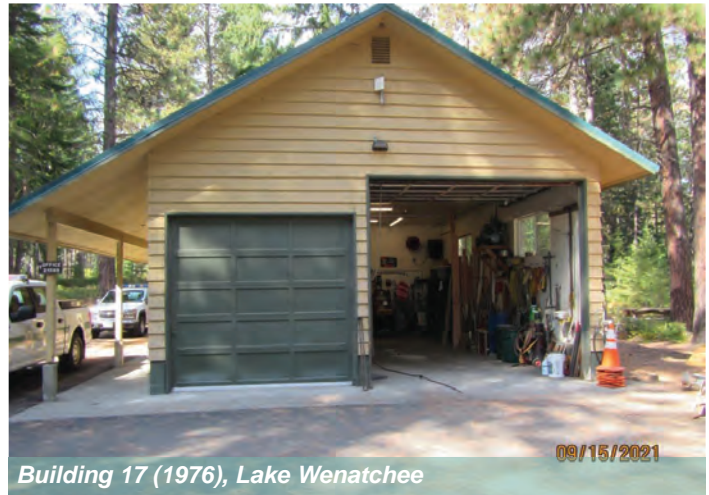
BS128 Snow Area Shop Building (1976)

This design was used at Fields Spring and Lake Wenatchee.

A concrete foundation supports the platform frame structure. Horizontal, beveled cedar siding with an 8-inch exposure and mitered corners clads the building. Metal vents are in the peaks of the gable ends.

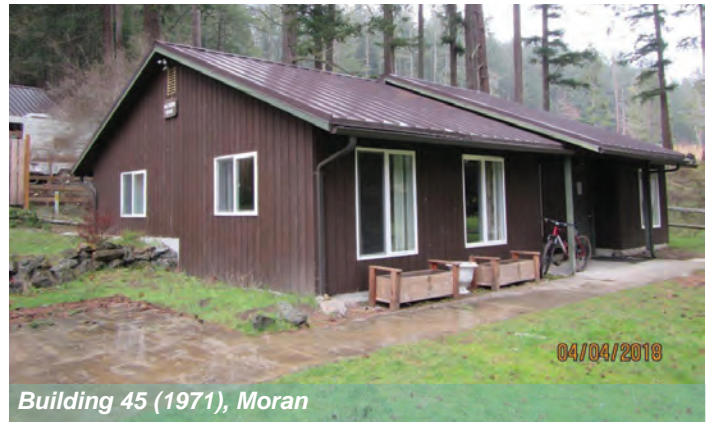
BS116 Infirmary (1970)

Design elements from this plan were used in BS115 Duplex, but both designs were prepared in 1970 and just month apart; this is the older design of the two. The design was used at Moran. See also Dwelling—Cabin, standard design BS032-3.

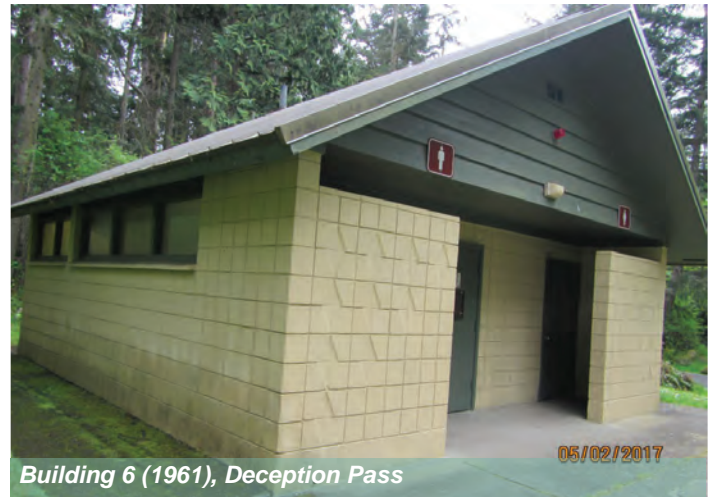
BS005 Small Day Use Comfort Station (1956, oldest resource)

Buildings built as early as 1956 (Deception Pass, building 5) pre-date this base design, indicating an earlier base design. The design remained in use through at least 1968 and was used at Deception Pass and Lake Sammamish.

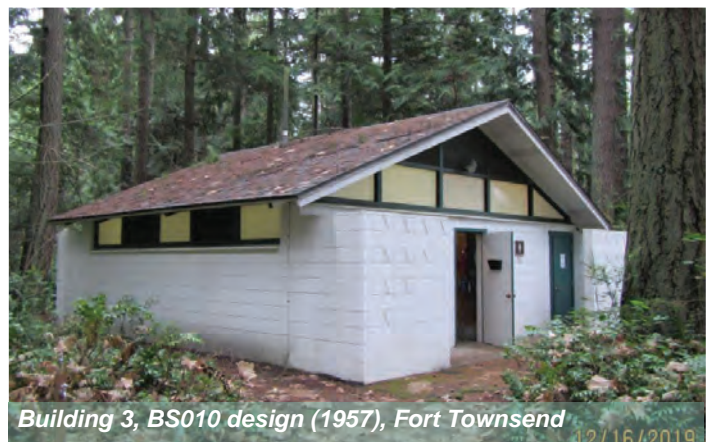
BS009 Standard Camp Area Comfort Station (1957, oldest resource)

There are no extant buildings associated with this design. BS009 predates and is similar to, just larger than, BS010 which does have two extant buildings. Due to the drawing dates, BS009 is treated as the base and BS010 a variation.

The interior layout is the same for each side with sinks and associated mirrors, toilet stalls (five women's, three men's), urinals (two), and a shower and dressing room along the inner mechanical chase wall.

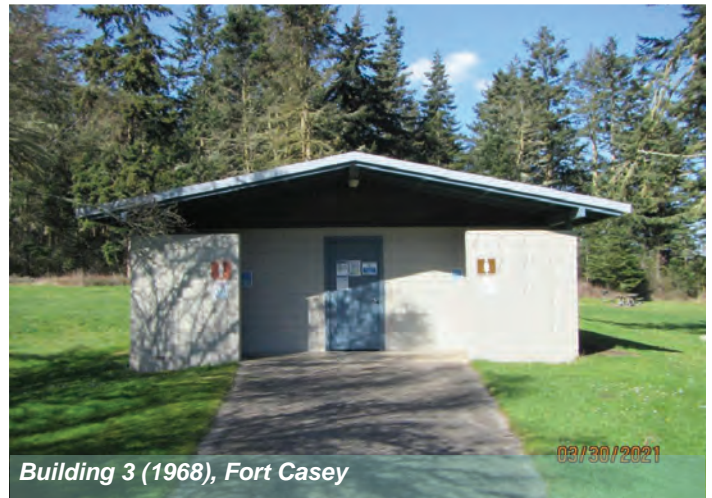
BS015 Small Day Use Comfort Station (1963)

This design was used at Fort Casey.

Interior layout is the same for each side with a sink and mirror, toilet stalls (three women's, two men's), and one urinal along the central pipe chase wall.

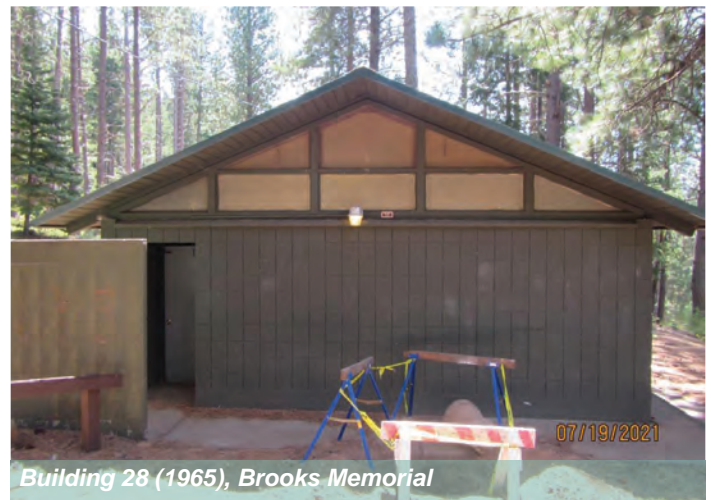
Building 28 (1965), Brooks Memorial

Internal layout consists of a U-shaped layout around the central mechanical chase. Toilet stalls (four) and urinals (two) are on one side with a large common shower area (five heads) on the other side and sinks and associated mirrors (six) towards the front end and on the shower side of the mechanical chase walls; there is an L-shaped bench mounted to the outer wall across from the sinks.

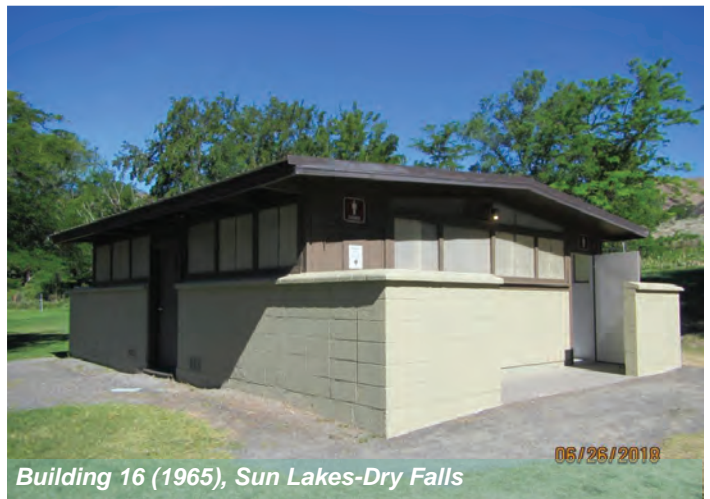
Building 16 (1965), Sun Lakes-Dry Falls

Internal organization consists of women's and men's restrooms on either side of a central pipe chase. Each restroom has a wall-mounted sink and an associated mirror placed close to the entrance, along with toilet stalls (two women's, one men's) and a urinal. Plywood clads the interior.

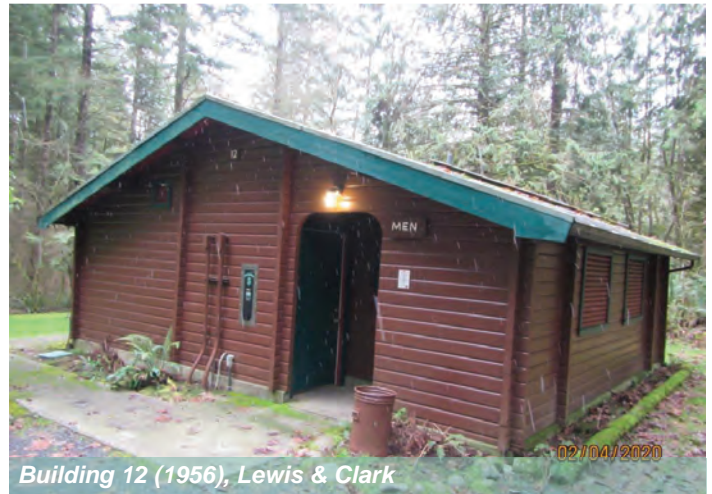
BS022 Comfort Station Large Western Standard with and without Showers (1952, oldest resource)

Buildings built as early as 1952 (Moran, building 4) pre-date this base design, indicating an earlier base design. The design remained in use through at least 1957. This design was used at Bay View, Lewis & Clark, Millersylvania, and Moran.

- Variations built at Millersylvania (buildings 24, 37) in 1957 are larger in size than the base design.

A concrete foundation supports the Pan-Abode (pre-cut log) structure.

Internal organization consists of dressing rooms at either end with central toilet rooms with toilet stalls (four women's, two men's), a sink, and two urinals. The dressing rooms have a bench around the outer walls. Concrete blocks are exposed at the interior. Harborite was specified to serve as screen material.

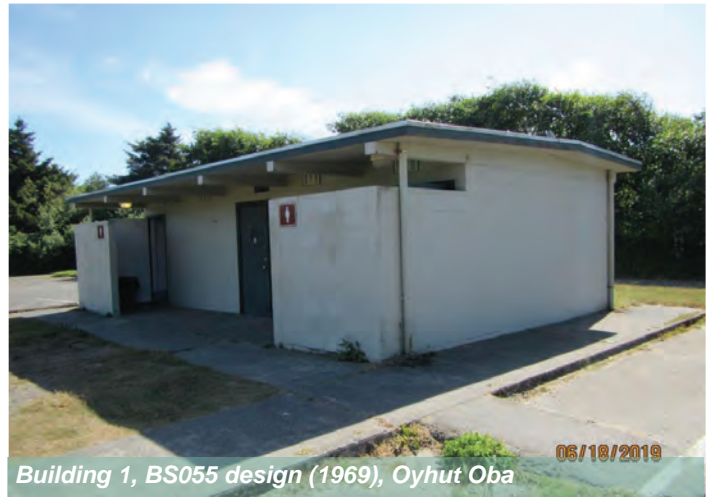
BS114 Group Camp Comfort Station (1969)

The main entrance is on the front facade and consists of a recessed vestibule set behind enclosing wing walls. Doorways (flush-panel, wood) at either end of the vestibule open to the women's and men's toilet rooms with a central doorway opening to the pipe chase. A wall mounted drinking fountain is located adjacent to this central doorway.

Internal organization consists of toilet stalls (five women's, three men's) along the pipe chase wall, with a half circle wall-mounted wash fountain (Bradley type) on the outer wall. Each toilet room has a universally accessible toilet stall.

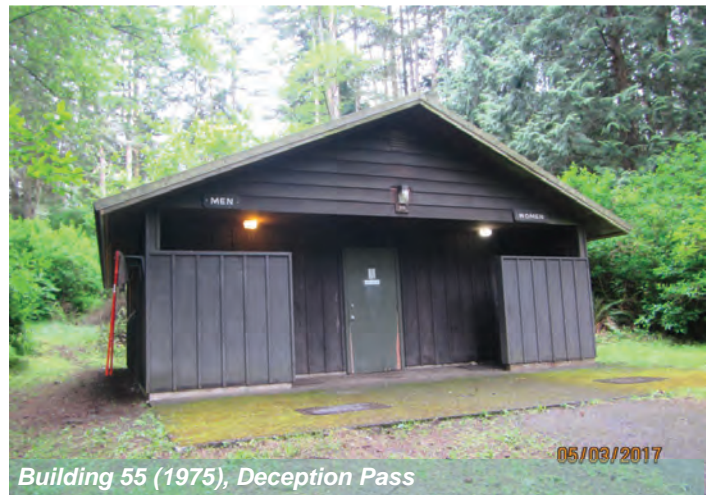
Building 55 (1975), Deception Pass

- BS123 Day Use Comfort Station (1973, updated 1978) provided a compact 15-by-33-foot plan building similar to BS114 but with expanded ADA toilet stalls and without the shower stalls. Cladding used re-sawn cedar plywood (plain face) with 1-by-2-inch battens and a 2-by-8-inch rough-sawn water table. The 1973 design had a 4:12 roof pitch with 4-by-6-inch purlin ends exposed at the gable ends. The pitch was

revised to 5:12 in 1978. Eaves are closed with resawn cedar plywood soffits. Interior finishes are 1-by-1-inch ceramic tile flooring and 4 1/4-by-4 1/4-inch ceramic wall tiles with plywood at the ceiling. This design was used at Camano Island, Dash Point, Fort Ebey, Griffith-Priday, Lake Sammamish, Lake Sylvania, Lake Wenatchee, Riverside, Scenic Beach, Spencer Spit, Twenty-Five Mile Creek, and Wallace Falls.

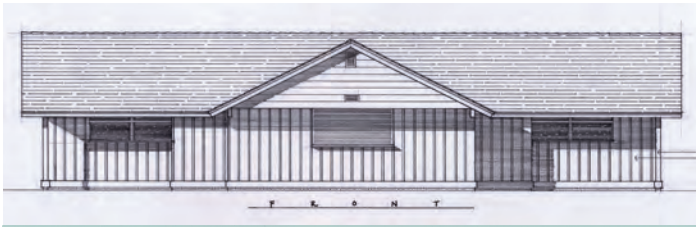
BS126

Internal organization consists of toilet stalls (three women's, two men's), a urinal (men's), three sinks (both), and showers. The men's side shower consists of a single room with three shower heads and benches along the outer walls. The women's side shower consists of three separate stalls each with a bench and shower head. A concrete floor extends throughout.

Examples built as early as 1969 (Lake Chelan, building 16) with the same base design but using concrete block rather than wood frame construction pre-date the base design, indicating an earlier design. This design was used at Alta Lake, Ginkgo, Ike Kinswa, Lake Chelan, Lake Sammamish, Lyons Ferry, Maryhill, and Sun Lakes-Dry Falls.

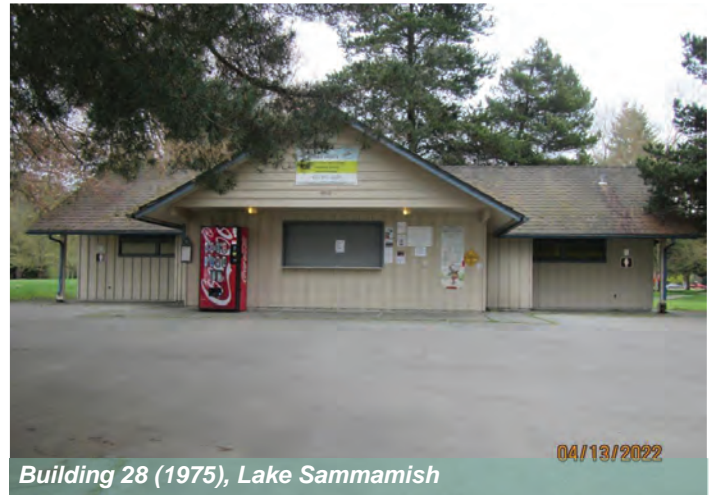
Building 28 (1975), Lake Sammamish

The secondary entrance features a pair of flush-panel doors providing access on the rear facade to the pipe chase. A personnel door on the side of the concessionaire provides staff access. A stainless steel serving counter projects from the wall at the concessionaire window, which consists of an aluminum roll-up door.

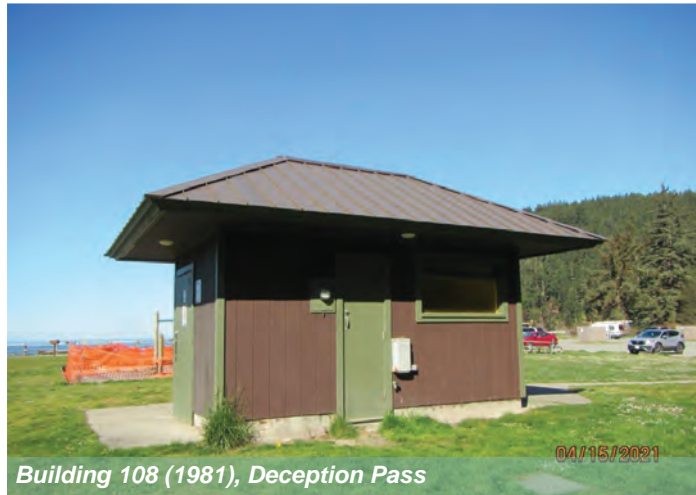
BS129 Comfort Station (1970)

Buildings built as early as 1970 (Blake Island, building 13) pre-date this base design, indicating an earlier base design. This design remained in use through at least 1982 and was used at Blake Island, Dash Point, Deception Pass, Federation Forest, and GRG–Kanaskat-Palmer.

A concrete foundation supports the platform frame structure. Resawn plywood with 1-by-2-inch battens at 12 inch centers clads the building. A rough sawn 2-by-8-inch water table wraps the base of the walls.

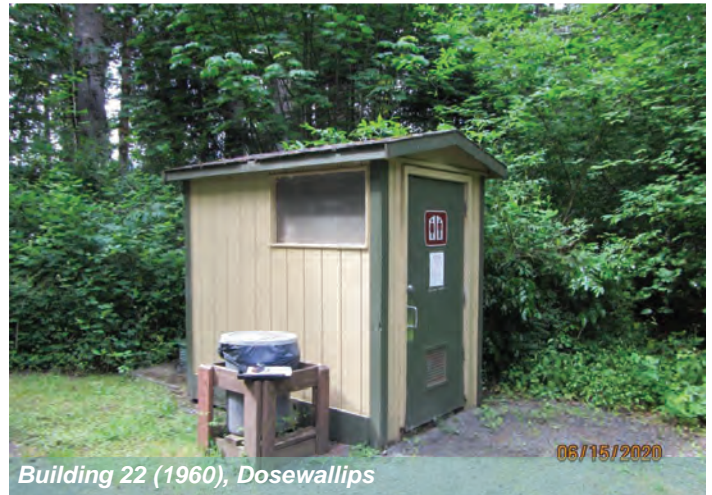
Building 22 (1960), Dosewallips

Examples built as early as 1960 (Dosewallips, building 22) indicate an earlier base design. The design remained in use through at least 1982 and was used at Blake Island, Deception Pass, Dosewallips, Fort Flagler, and Spencer Spit.

A concrete foundation supports the prefabricated structure. Panels comprised of 2-by-6-inch framing clad with 5/8-inch thick T-1-11 plywood (rough sawn) form the walls and floor.

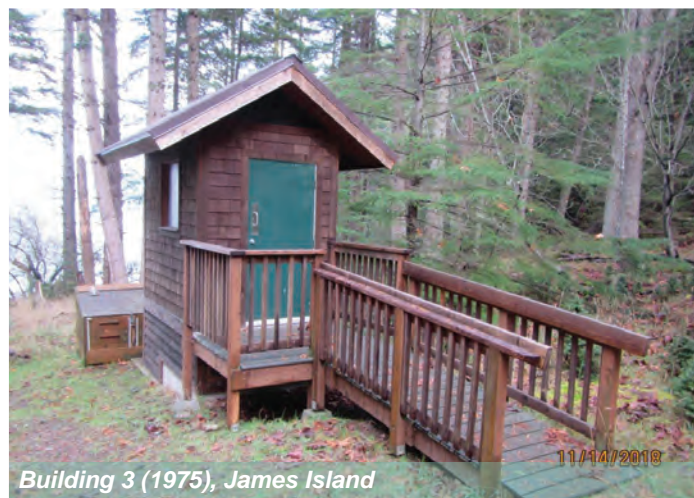
BS132 Composting Toilet Building (1975, oldest resource)

Examples built as early as 1975 (James Island, building 3) indicate an earlier base design. This design was used at Blind Island, James Island, and Sucia Island.

A pressure treated wood foundation supports the platform frame structure. T-1-11 siding, with 1-by-4-inch cedar corner boards, clads the building. Gable ends are clad with beveled cedar siding that has a 6-inch exposure.

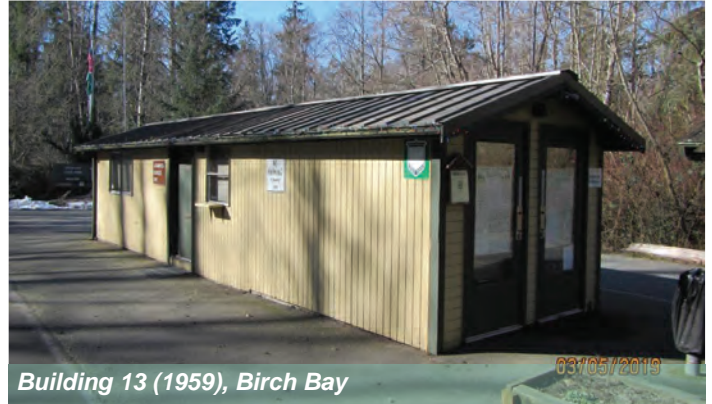
- BS STD Small Contact Station (1971) dated just a few days after the large contact station design. An example of BS STD Small built in 1959 (Birch Bay, building 13) indicates an earlier base design.

The 1971 design is the earliest known drawing showing the design. The design established a compact one-story utilitarian form building with a rectangular 28-by-12-foot plan, including the front canopy. A concrete walkway wraps around the building.

A concrete foundation supports the platform frame structure. Foundation depths varied with a minimum of 18 inches in Western Washington and 30 inches in Eastern Washington. Posts (4 by 4 inches) support the projecting 4-by-8-inch beams carrying the front canopy. Board and batten cedar siding comprised of 1-by-12-inch boards with 1-by-2-inch battens clads the building. Horizontal 10-inch bevel cedar siding with an 8-inch exposure clads the gable ends with a vent at the peak.

Fenestration was specified as anodized aluminum frames with 1/8-inch single-pane glass, on all facades. The front facade has a pair of tall single-light windows. Side facades feature a tall narrow window flanking the entrance providing day lighting for the staff counter area with a pair of single-light windows towards the back of the building at the staff office space. The back facade has two pairs of tall windows. Window openings feature narrow casings. Side and rear windows are clad with Extrude-A-Lock sunscreens. An air conditioner is located on the rear facade.

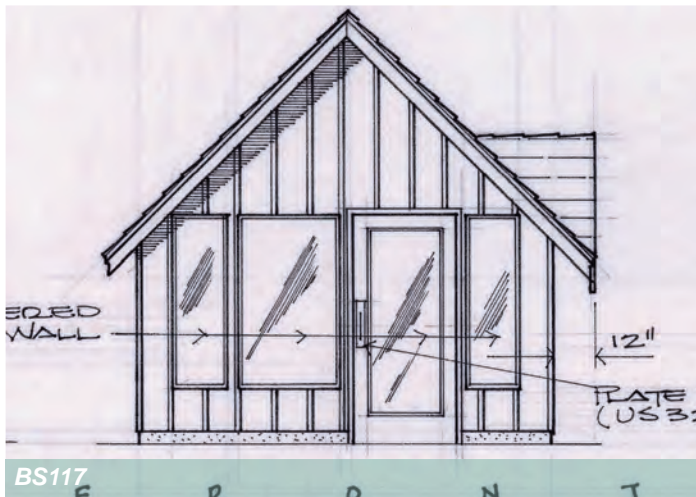
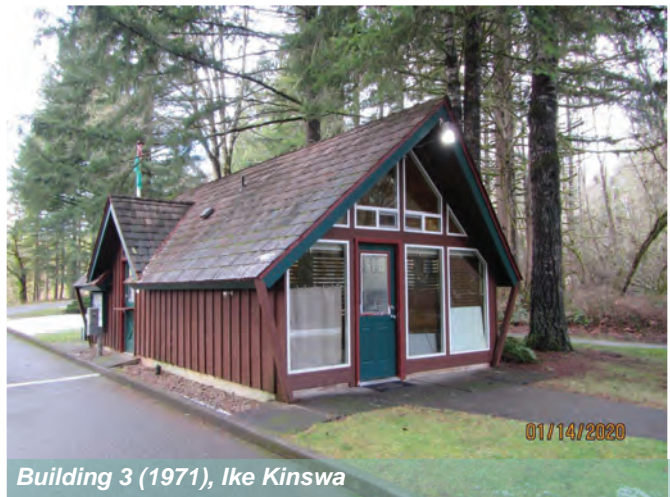
BS117 Contact Station (1971, oldest resource)

Buildings built as early as 1971 (Ike Kinswa, building 3) pre-date this base design, indicating an earlier base design. The design remained in use through at least 1981 and was used at Battle Ground Lake, Ike Kinswa, Manchester, Scenic Beach, and Twin Harbors.

A concrete foundation supports the platform frame structure. Resawn cedar plywood siding with 1-by-2-inch battens at 12 inch centers clads the building.

Internal organization consists of a front reception area with a staff counter and a single toilet room. A pocket door separates this front area from the back staff office space. The reception area has a concrete floor with vinyl over the concrete in the staff area.

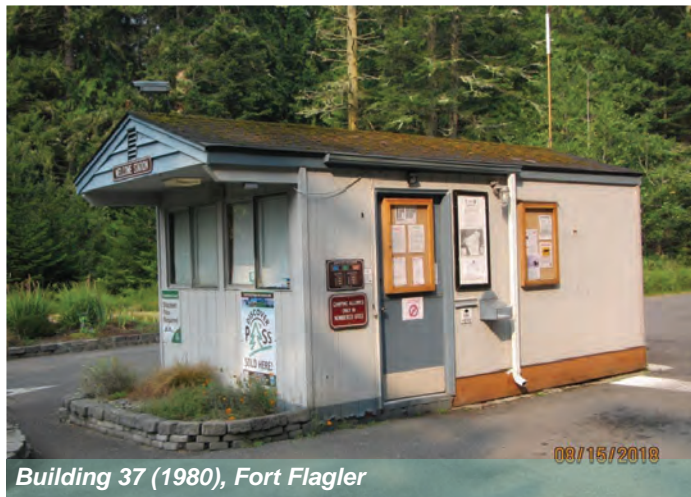
BSxxx Relocatable Contact Station (1980, oldest resource)

This design did not receive a standard design number. The example built in 1980 (Fort Flagler, building 37) provides the estimated date for the base design.
