WASHINGTON STATE PARKS ARCHITECTURE

1943–1985

PREPARED BY
NORTHWEST VERNACULAR, INC.

Washington State Parks and Recreation

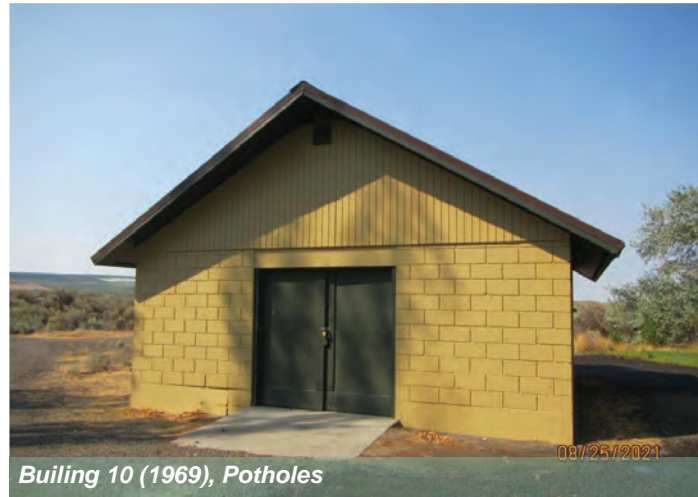
BS054 (1968)

The 1968 design established a one-story utilitarian form building with a rectangular 19-foot 11 5/8-inch-by-11-foot 11 5/8-inch plan.

A concrete foundation supports the concrete block structure. Blocks (8 by 8 by 16 inch) are laid up in a stacked bond with a Dorman slot. Horizontal bevel cedar siding (7 inch exposure) clads the gable ends with a vent in the peak.

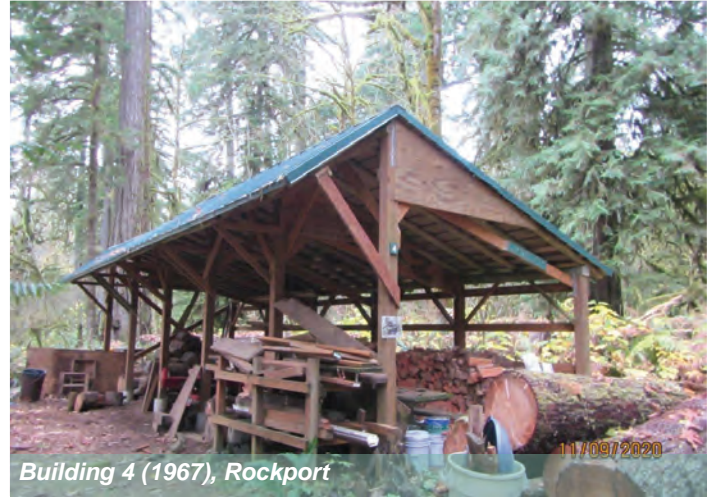
BS134 Equipment Shed (1967, oldest resource)

Buildings built as early as 1967 (Rockport, building 4) pre-date this base design, indicating an earlier base design.

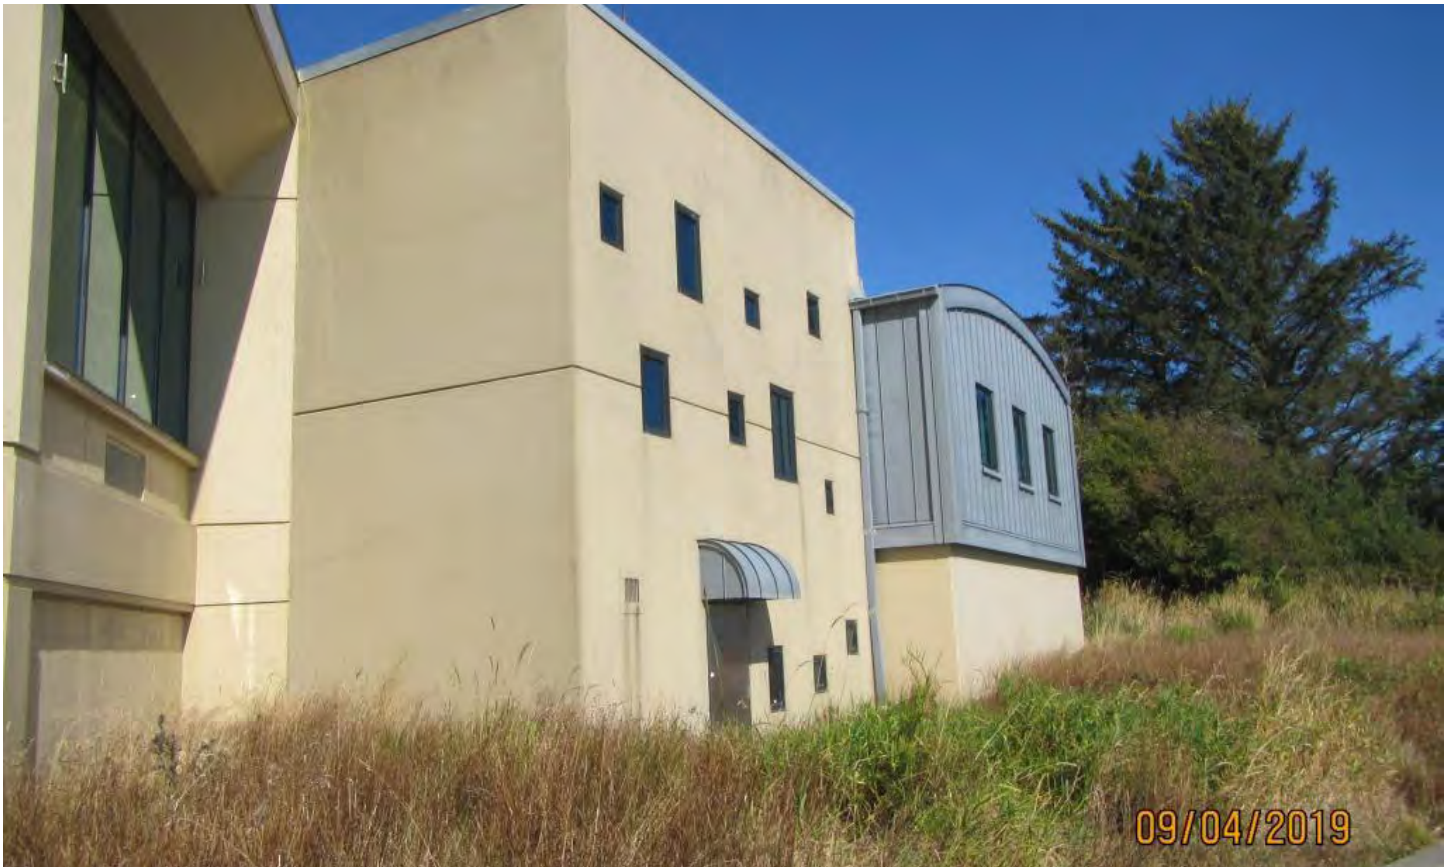
Crown Point, Vista Dome

Building 4 (1953) is individually eligible for National Register of Historic Places listing. Conduct an intensive level survey of the resource.

Criterion A is applicable. The building is associated with the interpretation of Grand Coulee Dam (1942) for tourism purposes. Although not directly associated with the dam construction, the vista dome is associated with the transitional period of state park development and the park was developed specifically for this vista house. A May 29, 1951, article "State Building Eyed for Point" in *The Spokesman-Review* identified the intent to provide park visitors "with a thrilling scene contrasting the placid Lake Roosevelt and the turbulent flood-season downstream Columbia." The original intent had been for a larger interpretive facility.

Criterion C is applicable. The New Formalist style building is distinctive within the post-World War II transitional period of architectural development within state parks. Based on the building's in-house drawing by C. L. Brown, a State Parks employee, and attribution to Donn Sibold as the designing architect, it does convey the expression of significant aesthetic ideals or preferences (high artistic value). A February 13, 1953, article, "Foundling Road May Receive a Father from Legislature" in the *Spokane Chronicle* noted that, "within a few days, the parks officials announce, a lookout will be built on the point for tourists at a cost of \$13,000 to \$14,000." An October 31, 1953, *Spokane Chronicle* article entitled, "Hearing is Set" noted that "the state has recently completed construction of a vista house on Crown Point above Coulee Dam, which is reported to have cost approximately \$75,000." Further research is recommended to determine the relationship and roles of architect Donn Sibold and C. L. Brown.

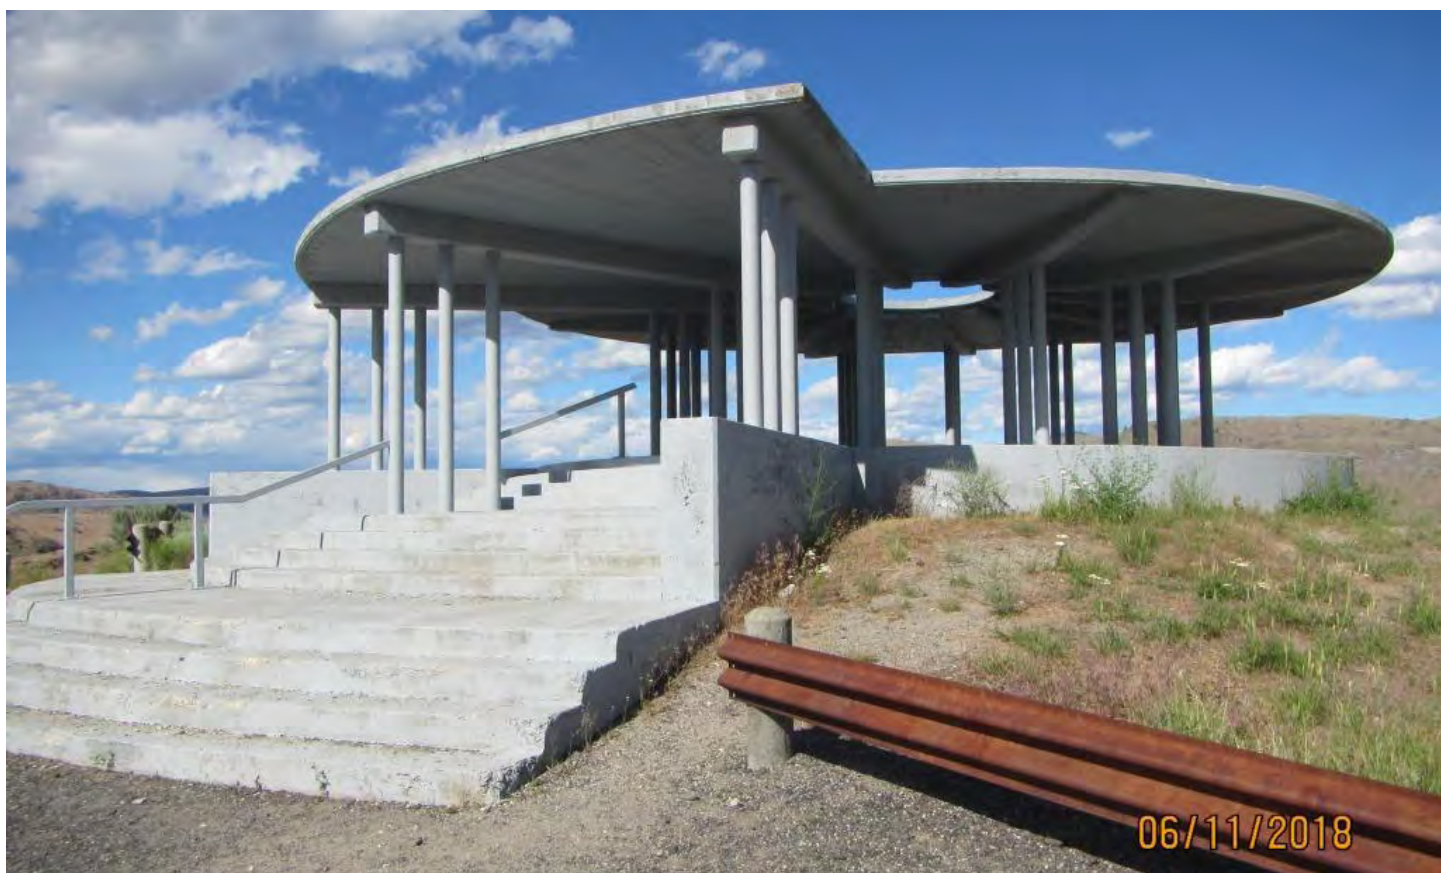
Ginkgo, Interpretive Center

Building 3 (ca. 1938, 1952) is individually eligible for National Register of Historic Places listing. Conduct an intensive level survey of the resource; this should be coordinated with the recommendations in Parks Analysis.

Criterion A is applicable. The building is associated with the interpretation of the Ginkgo Petrified Forest, the expanded exhibit space to include the collection of Frank Bobo of Cle Elum, and as an early state park resource reflecting the influence of the Mission 66 Program. During the C.C.C. tenure of the park, expansion of the museum was considered; however, not implemented.

Criterion C is applicable. Based on the building's PNW Modern design and materials, it is unique and distinctive, and does convey significant technical or aesthetic achievements (work of a master) and the expression of significant aesthetic ideals or preferences (high artistic value) characteristic of state parks architecture during the 1950s, transitioning from the Rustic style to Modernism. Designed by the significant architect Robert Billsbrough Price, the addition more than doubled the original building's size and completely redesigned the exterior of the original building into a single cohesive design. Carver Lowell Baker was the state park architect working on the project and stamped the drawings.

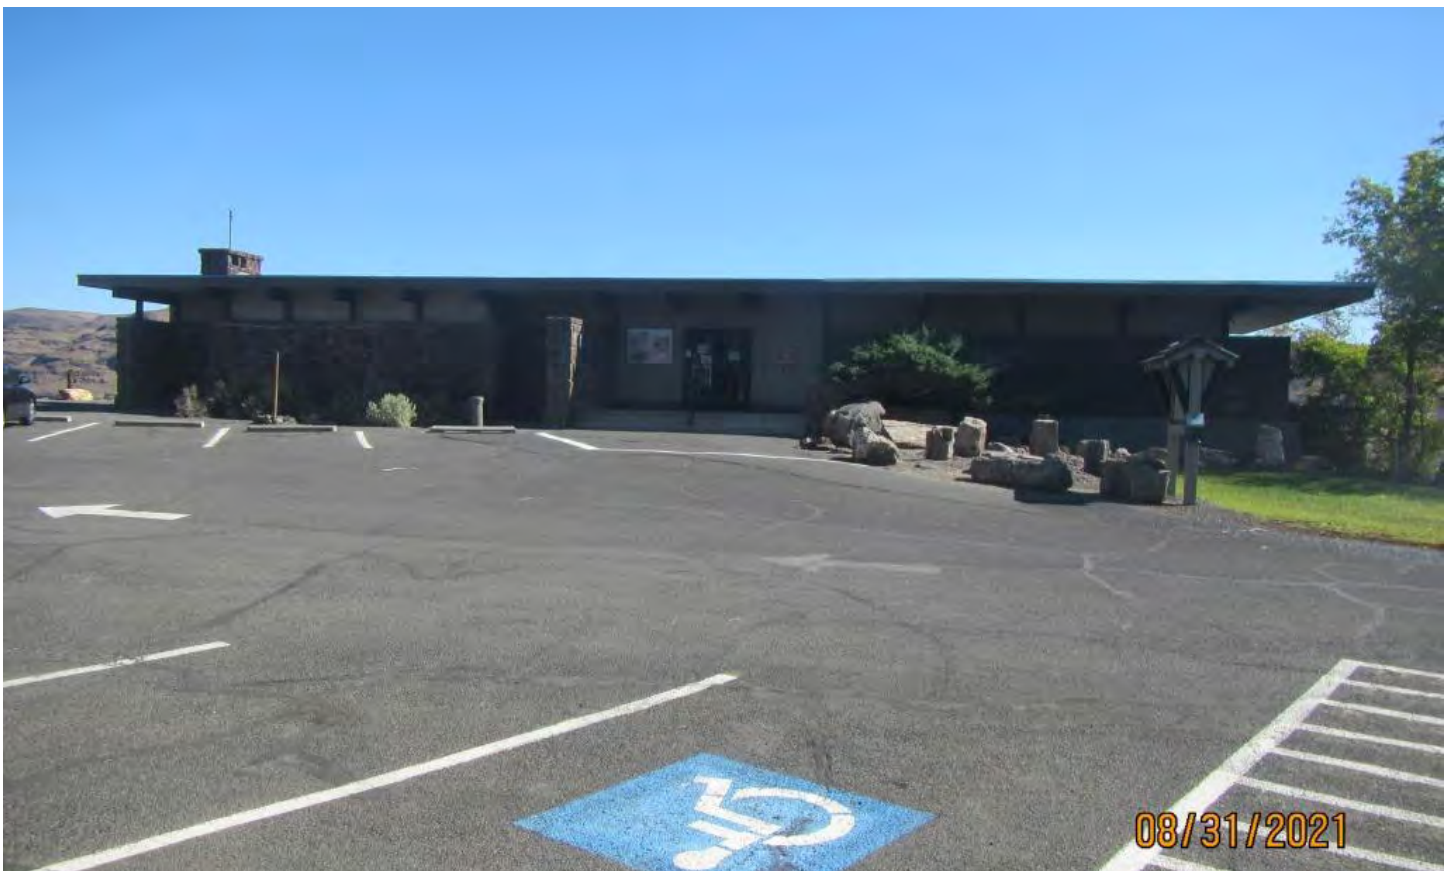
Lake Sammamish, Picnic Shelter

Building 27 (1975) is individually eligible for National Register of Historic Places listing. Conduct an intensive level survey of the resource; this should be coordinated with the recommendations in Parks Analysis.

Criterion A is applicable. The building is associated in an important way with the 1950s development of Lake Sammamish Park.

Criterion C is applicable. The building's PNW Modern style design and material usage (stone and glulam) are characteristic of the 1950s transition from the Rustic style to Modernism in the design of state park facilities. The building's unique design and form convey significant aesthetic achievements (work of a master) and convey the expression of significant aesthetic ideals and preferences (high artistic value).

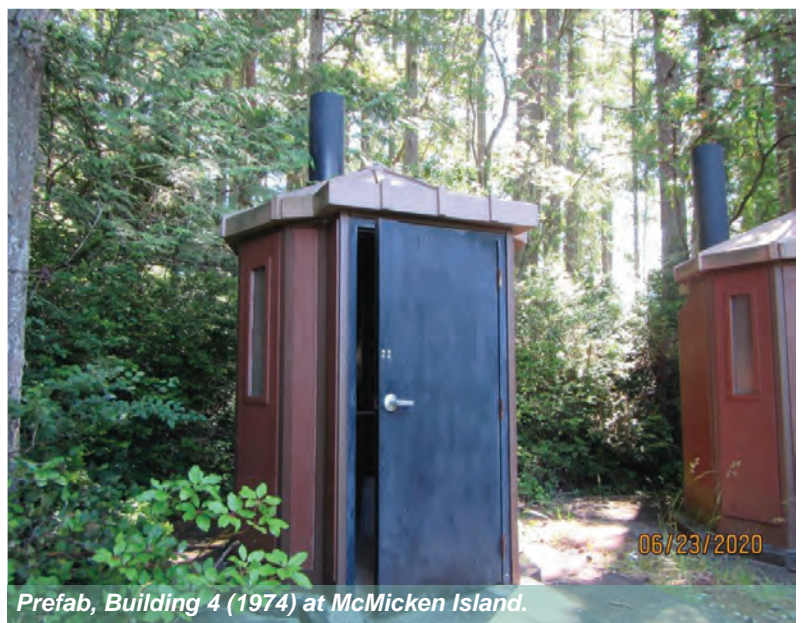
This group of resources consist of toilets with a precast concrete vault and base with fiberglass or similar for the walls and roof. They were used in Blake Island, McMicken Island, and Twanoh between 1974 and 1980. As with other construction methods, a resource being precast concrete does not imply automatic National Register eligibility. The majority of these are not yet 50 years old. None of these would be individually eligible for National Register listing but should be evaluated in the context of the state park.

Prefab, Building 4 (1974) at McMicken Island.

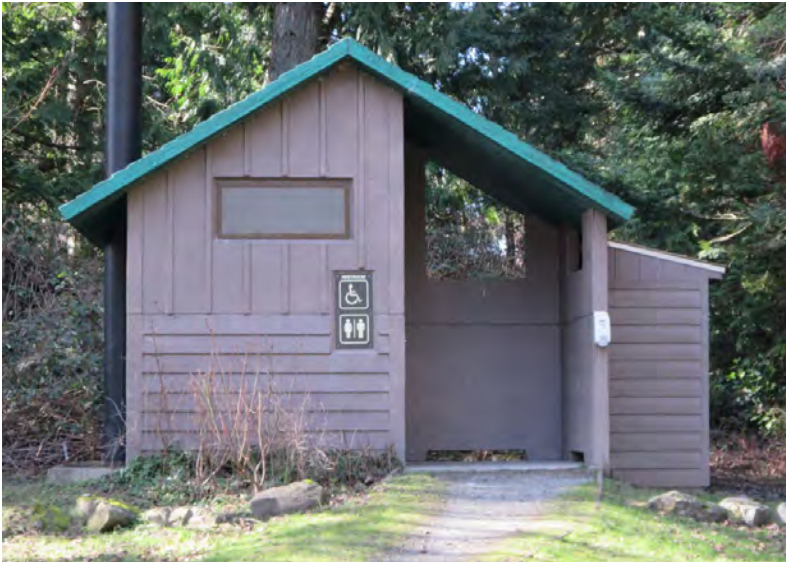
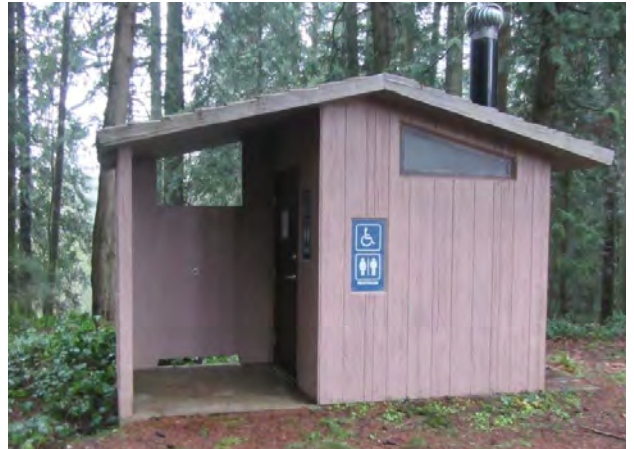
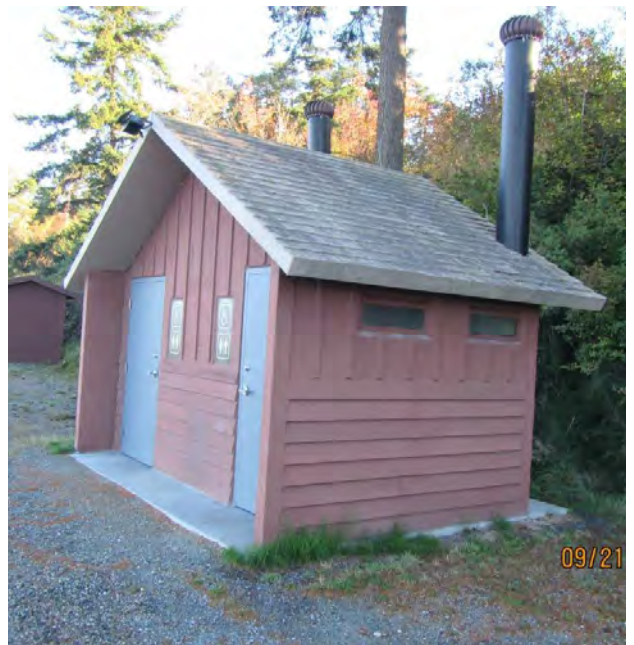
As with other construction methods, a resource being prefabricated by the CXT company does not imply automatic National Register eligibility. CXT, Incorporated is a company that specializes in precast concrete buildings and structures. State Parks prepares the site and buys the building after selecting the model from the manufacturer. These are used exclusively for comfort stations. The majority of these are not yet 50 years old. None of these would be individually eligible for National Register listing but should be evaluated in the context of the state park. Standard plans utilized include Cascadian, used at Larrabee, Palouse to Cascades, Rainbow Falls, and Moran and Double Cascadian used at Bay View.

Clockwise from upper left: Building 15 (1984) at Larrabee; Building 8 (1954) at Paradise Point; and Building 19 (1980) at Bay View.

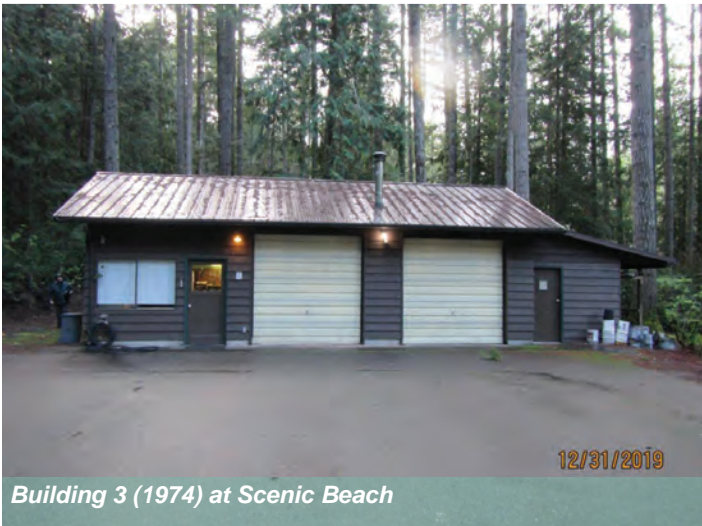
Building 3 (1974) at Scenic Beach

- BS038 Cooking Shelter Standard Design (1954) saw usage from 1954 through 1985, with at least 36 resources built statewide using this design across 24 parks. Most retain integrity. They were not developed as a unique resource, but as a supporting component within a park. Resource examples were identified as EC in the inventory analysis for Palouse Falls, ELC Camp Wooten, Penrose Point, and Saltwater. Refer to Park Analysis for recommendations on the overall park eligibility analysis. The oldest extant example is Alta Lake building 12, built in 1954. There are no individual resources recommended as National Register eligible.

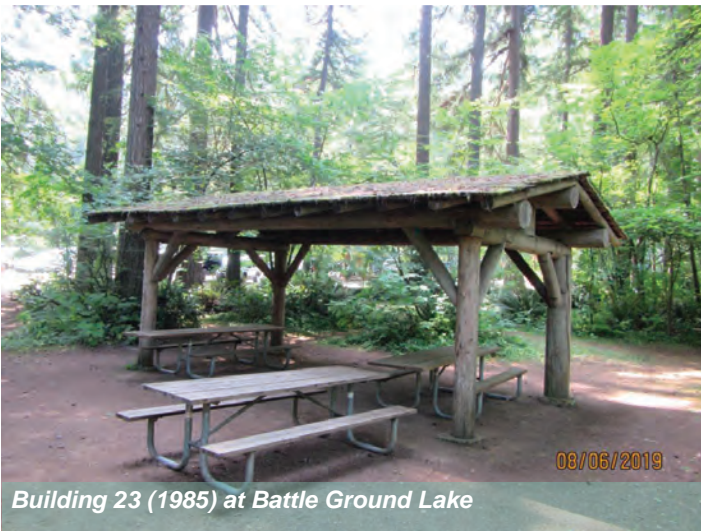
Building 23 (1985) at Battle Ground Lake

- BS130A Log Kitchen Shelter Intermediate Size (ca. 1956) saw usage from 1956 through 1985, with seven resources built in western and central Washington across six parks. All are intact. They were not developed as a unique resource, but as a supporting component within a park. Resource examples were identified as EC in the inventory analysis for Lake Wenatchee; however, this resource (building 15, built 1983) is not 50 years old and not exceptionally significant. Refer to Park Analysis for recommendations on the overall park eligibility analysis. The oldest extant example is Millersylvania building 58, built in 1956. There are no individual resources recommended as National Register eligible.

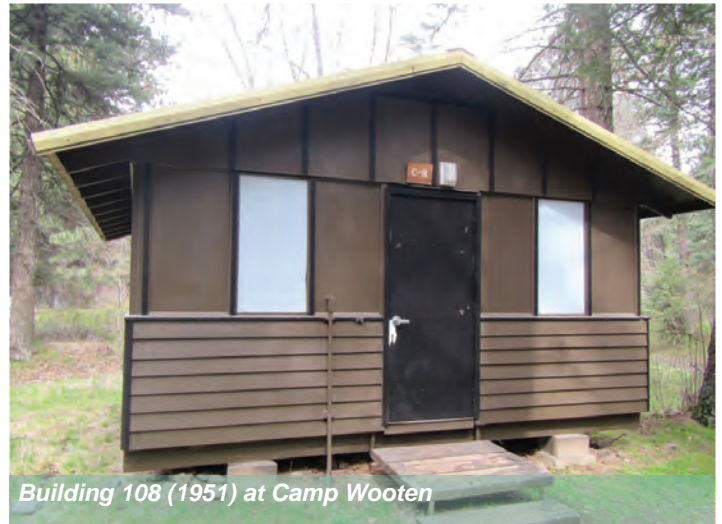
Building 108 (1951) at Camp Wooten

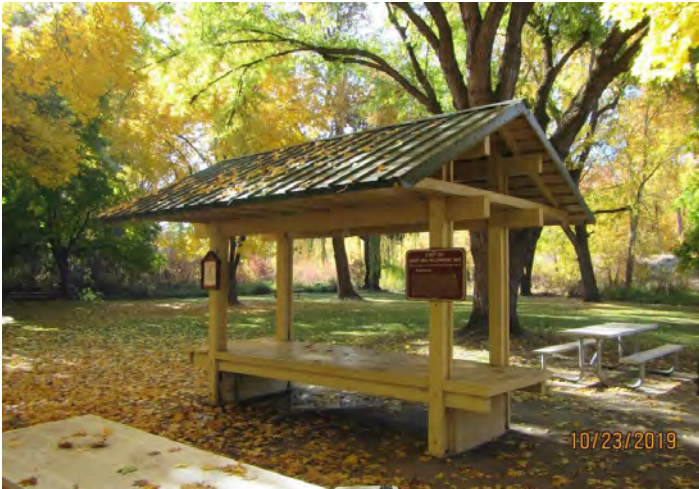
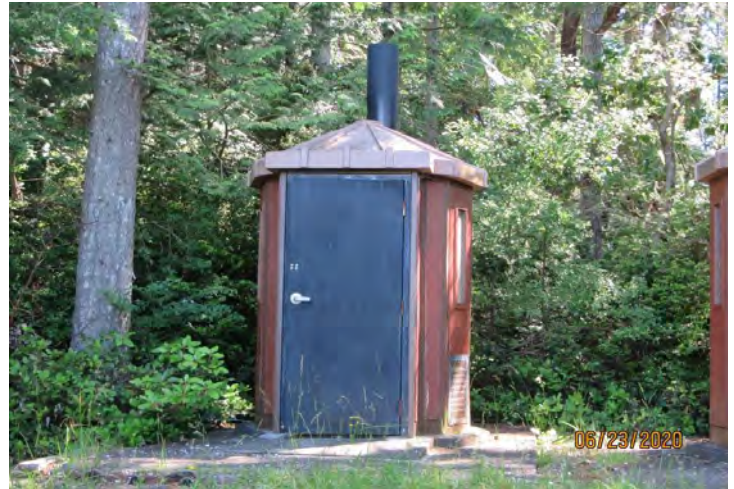
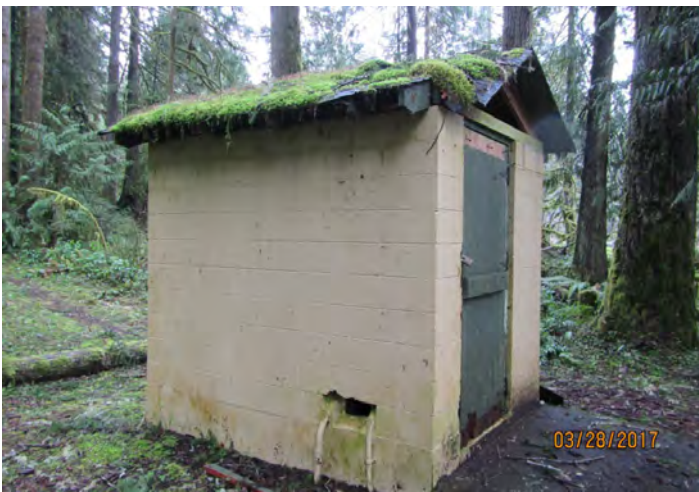
- NA-23, three resources built between 1950 and 1965. This group is distinct for the Modern style design and was used in Yakima Sportsman (buildings 8–9, 1950) and Lewis & Clark Trail (building 8, 1965). The resources are not individually eligible. Refer to Parks Analysis for additional information.
- NA-44, four resources built between 1974 and 1980. These precast concrete vault toilets were used at McMicken Island, Blake Island, and Twanoh. These are not 50 years old and none were identified within an eligible historic district.
- NA-53, four resources built between 1960 and 1974. These storage sheds occur as both concrete block and wood frame versions. They have both mechanical and storage functions. They were used at Mount Spokane, Potlatch, Federation Forest, and Westport Light. These are not individually eligible, and none were identified within an eligible historic district.

Clockwise from upper left: Building 8 an NA-23 (1950) at Yakima Sportsman; Building 4 an NA-44 (1974) at McMicken Island; and Building 4 an NA-53 (1961) at Potlatch.

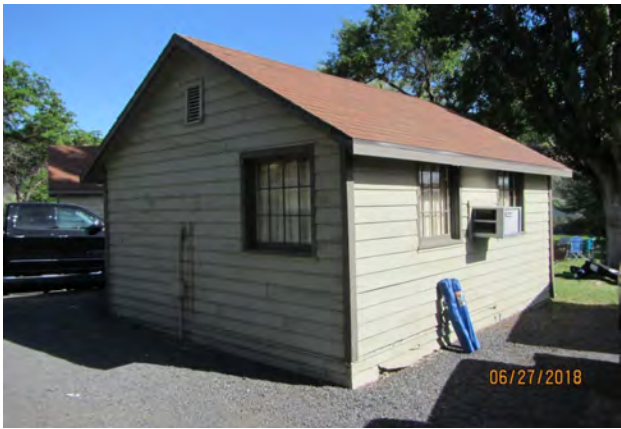
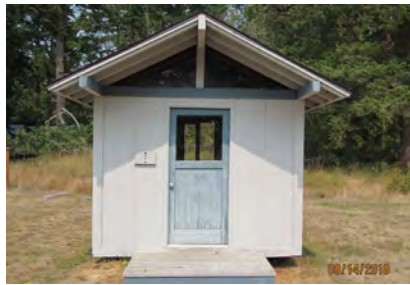
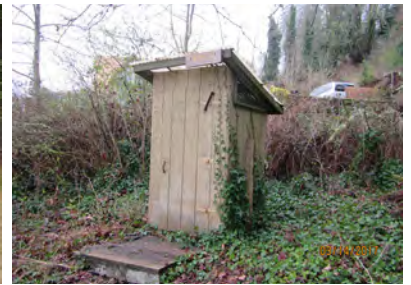
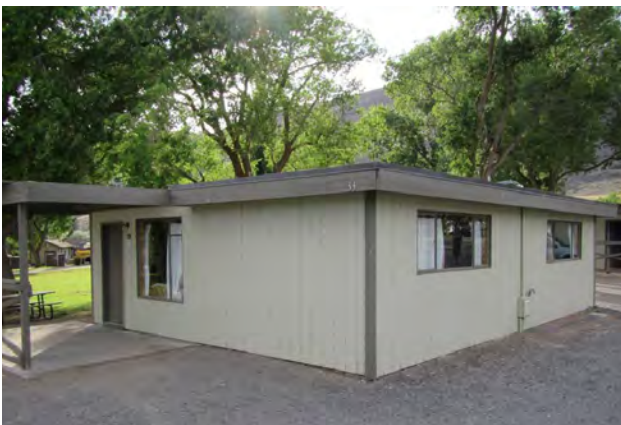
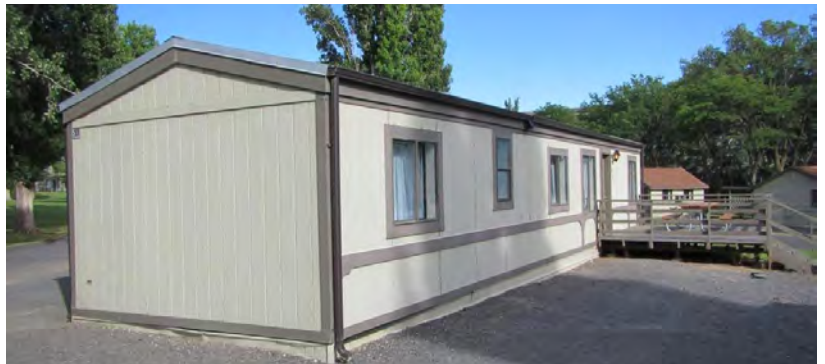
- NA-13, 11 resources built in 1970, as music rehearsal buildings at Fort Flagler. Refer to the Park Analysis for additional information. None are individually eligible and there is no eligible historic district.

- NA-47, 17 resources built from 1964 to 1985, built at 11 parks statewide, including Rockport, Camano Island, Turn Island, Clark Island, Jarrell Cove, Lake Sylvia, Sucia Island, South Whidbey, Illahee, Stuart Island, and Lewis & Clark Trail. These are a simple shed roofed pit toilet structure. Some are also used for storage. They are EC at Lewis & Clark Trail, refer to the Parks Analysis for additional information. None are individually eligible.

Clockwise from lower left: Building 111 an NA-10 (1959) at Sun Lakes-Dry Falls; Building 83 an NA-9 (1947) at Sun Lakes-Dry Falls; Building 906 an NA-13 (1970) at Fort Flagler; Building 911 an NA-47 (1980) at Illahee; and Building 120 an NA-11 (1959) at Sun Lakes-Dry Falls.
